# A Case Study of the High-speed Train Crash Outside Santiago de Compostela, Galicia, Spain

Rebecca Forsberg, PhD;<sup>1</sup> José Antonio Iglesias Vázquez, MD, PhD<sup>2</sup>

Forsberg R, Vázquez JAI. A case study of the high-speed train crash outside Santiago de Compostela, Galicia, Spain. *Prehosp Disaster Med.* 2016;31(2):163-168.

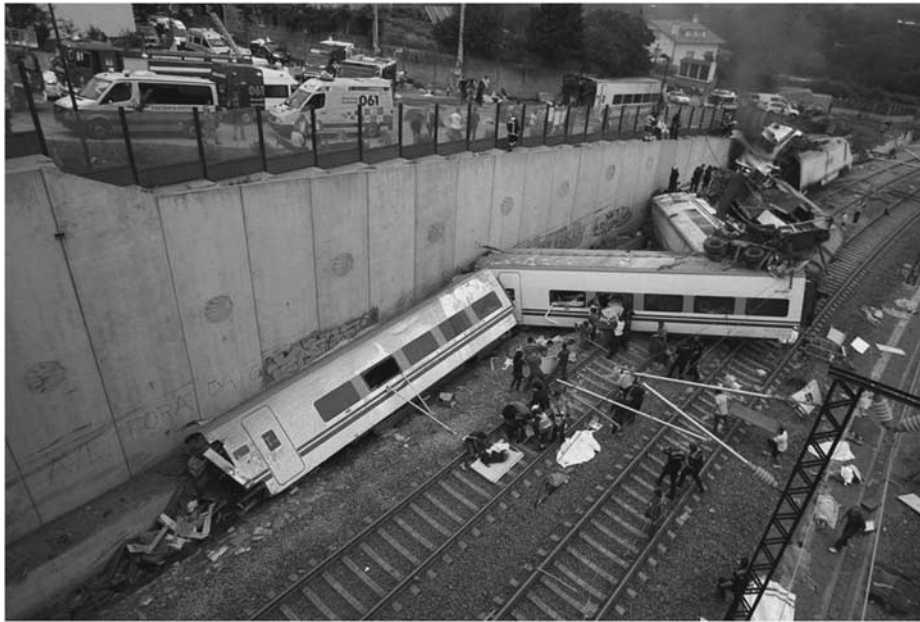
**Figure 1.** The Train Crash in Angrois, Outside Santiago de Compostela, Spain in 2013. (Photo: José Antonio Iglesias Vázquez; 061-Galicia).

(recommended maximum speed for the curve 80 km/hour) pulling the other 12 carriages (eight passenger carriages, one dining carriage, one generator carriage, and two locomotives) off the track (Figure 1). Four carriages overturned and the rear generator and engine caught fire. One passenger carriage was thrown approximately four to five meters up onto the road above the embankment.<sup>11</sup>

Furthermore, the fact that one of the carriages was thrown up on the road above the embankment (Figure 1) by the massive forces cannot be disregarded. Also, four of the carriages overturned, an occurrence that increases the lethality and injury risk.<sup>16,19</sup> Because the rail carriages were not equipped with seat belts, the passengers most likely were thrown against various structures and into each other during the crash phase, which in other studies has proven to be an inducing factor for the emergence of injuries<sup>16,17,20,21</sup> (an experience that has been described as being in a tumble dryer).<sup>21,22</sup>

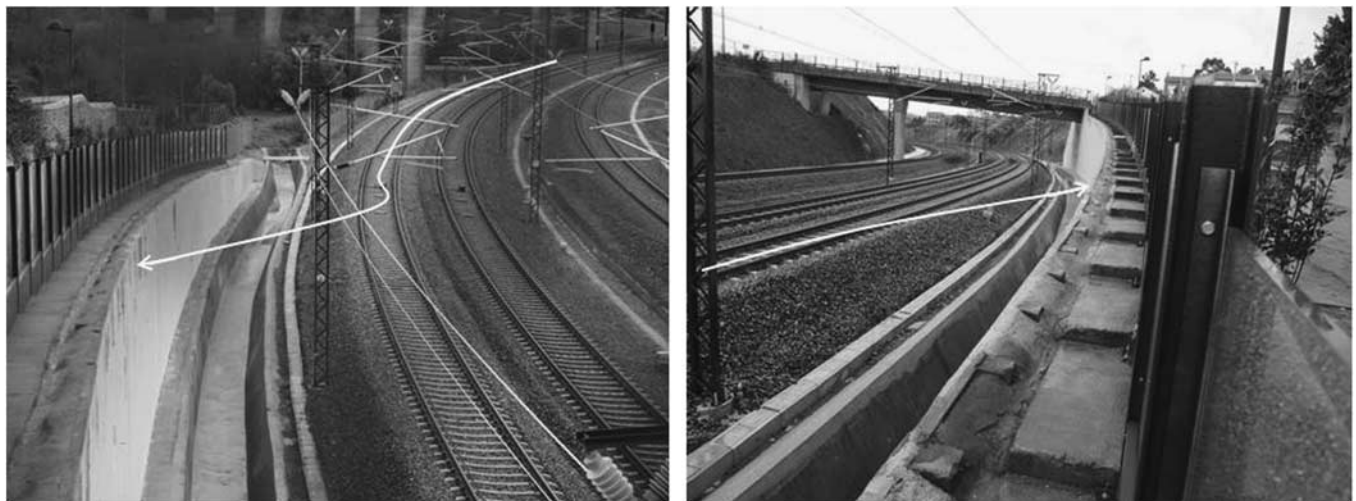
Two hundred and twenty-two unrestrained people (218 passengers and four crew members) were on board the train when it derailed on the route from Madrid to Ferrol (Spain) on July 24, 2013. The crash occurred at 8:41 PM in Angrois, just outside Santiago de Compostela, Spain. The second carriage (front generator) of a high-speed train set derailed in a curve (Figure 2) at a speed of approximately 180 km/hour

Some of the carriages slid against a sharp edge of a water chute (Figure 2) that ran alongside the tracks. This resulted in extensive exterior deformations on the carriages (Figure 3). Additionally, the interior structures loosened in several carriages, even those that did not slide against the water chute (Figure 4).

**Figure 2.** The Curve from Different Directions Where the Train Set Derailed. Observe the sharp edge of the water chute (right). (Photo: Rebecca Forsberg).

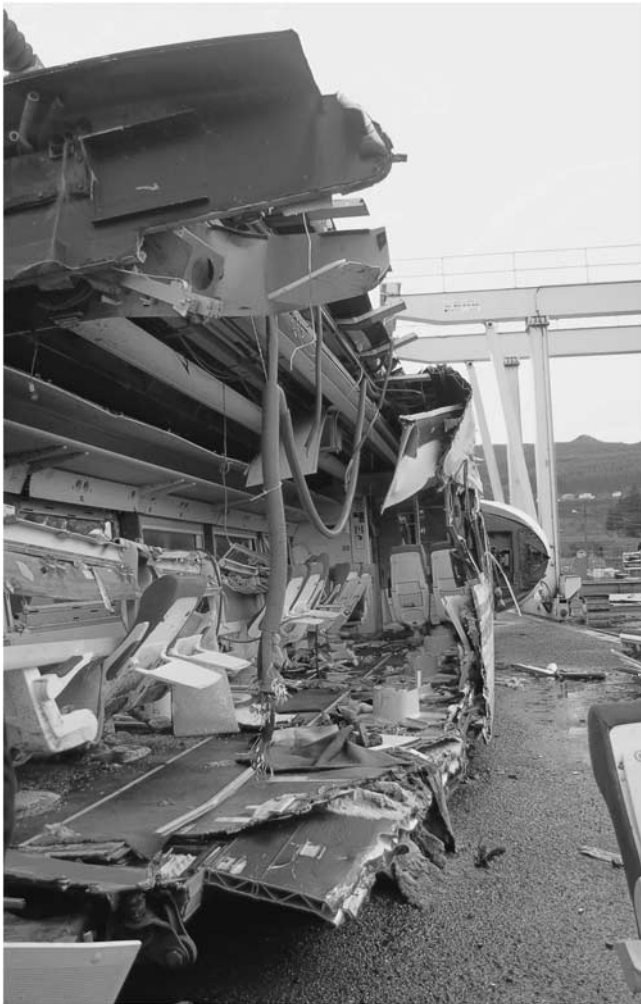
**Figure 3.** The Sharp Edge Caused Extensive Damage to the Carriages Exterior and Interior. (Photo: Rebecca Forsberg).

The crash in Angrois revealed that improved passenger protection also needs to include: improved high-velocity exterior crashworthiness; an injury reducing environment; firmly attached interiors and secured belongings; compartmentalization strategies to minimize the occupant's impact velocity (eg, table configurations or smaller compartments); and opportunities for passenger to be seated during the crash phase (eg with safety belts).

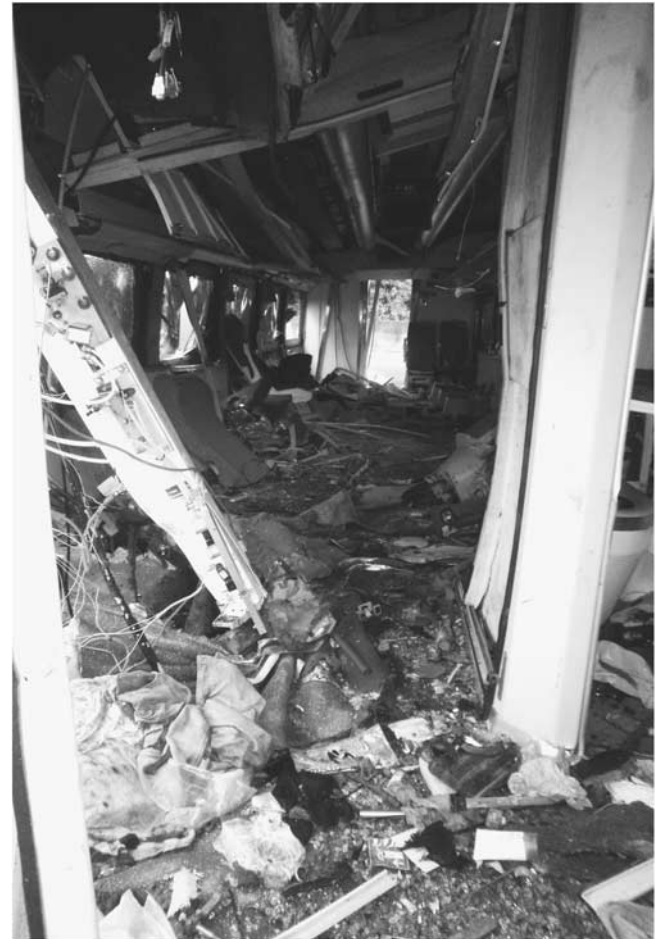
**Figure 4.** Interior Debris Included Loosened Interior Structures, Luggage, and Passengers. (Photo: Rebecca Forsberg).

Loosened interiors and unsecured luggage also can cause injuries in a crash;<sup>16,17,21,23</sup> Figure 4 leaves little doubt that this was also the case in this crash. The train set did not have sealable luggage hatches, like in airplanes, allowing suitcases to fly around as projectiles, a factor causing injuries in previous crashes.<sup>17,19,21,23,24</sup> These interior shortcomings indicate that methods to improve interior safety to reduce morbidity and mortality of future crashes merit further investigation.<sup>16,20,17,25</sup>
