Corrosion of a silver Negus tracheostomy tube

C. A. AYSHFORD, F.R.C.S., R. M. WALSH, F.R.C.S.(ORL), D. W. PROOPS, B.D.S., F.R.C.S.

Key words: Tracheostomy, Prosthesis failure

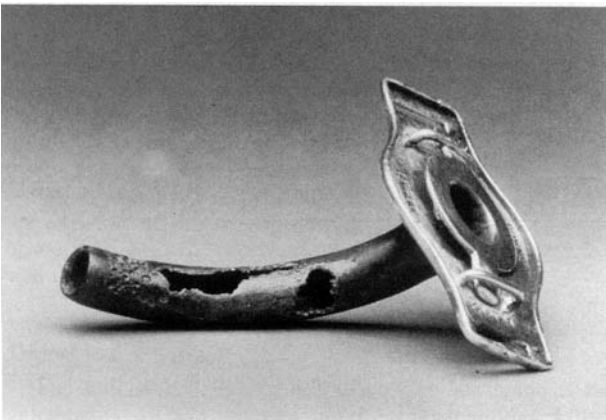
FIG. 1

This case is unique as the corrosion occurred in the outer tubing of the silver Negus tracheostomy tube. This part was made with standard silver, which contains a minimum of 92.8 per cent silver, copper and a trace of phosphorus. This is then silver-plated.

In the previous reported cases the possible causes of corrosion proposed included, cleaning with a corrosive fluid such as sodium hypochlorate solution and prolonged exposure to alkaline bronchial secretions. In this case, the authors believe the corrosion was probably a result of the tracheostomy tube being constantly exposed to bronchial secretions for such a prolonged period without cleaning. This is against the advice of the manufacturer, who suggest regular removal and cleaning with a non-abrasive and non-corrosive cleaner such as warm soapy water and a soft cloth. A fault in the manufacture should also be considered, as previous tracheostomy tubes left *in situ* for this length of time had not displayed this corrosion.

Silver Negus tracheostomy tube showing corrosion of the main body of the outer tube.

It would appear, from reviewing the previous reports, that standard silver is still the metal of choice in the manufacture of these tracheostomy tubes, but as shown by this case, careful attention should be paid to the manufacturer's instructions in the care of these tracheostomy tubes.
