Original Article

Cite this article: Happel CM, Zunzunegui Martínez JL, del Cerro MJ, Schranz D, Khalil M, Ballesteros F, Pardeiro CA, Bertram H, Beerbaum P, and Haas NA (2019) A word of caution: diabolic behaviour of AndraStents®: inflation of supporting balloon leads to “diabolo”-misconfiguration of the stent. *Cardiology in the Young* 29: 972–976. doi: [10.1017/S1047951119001264](https://doi.org/10.1017/S1047951119001264)

A word of caution: diabolic behaviour of AndraStents®: inflation of supporting balloon leads to “diabolo”-misconfiguration of the stent

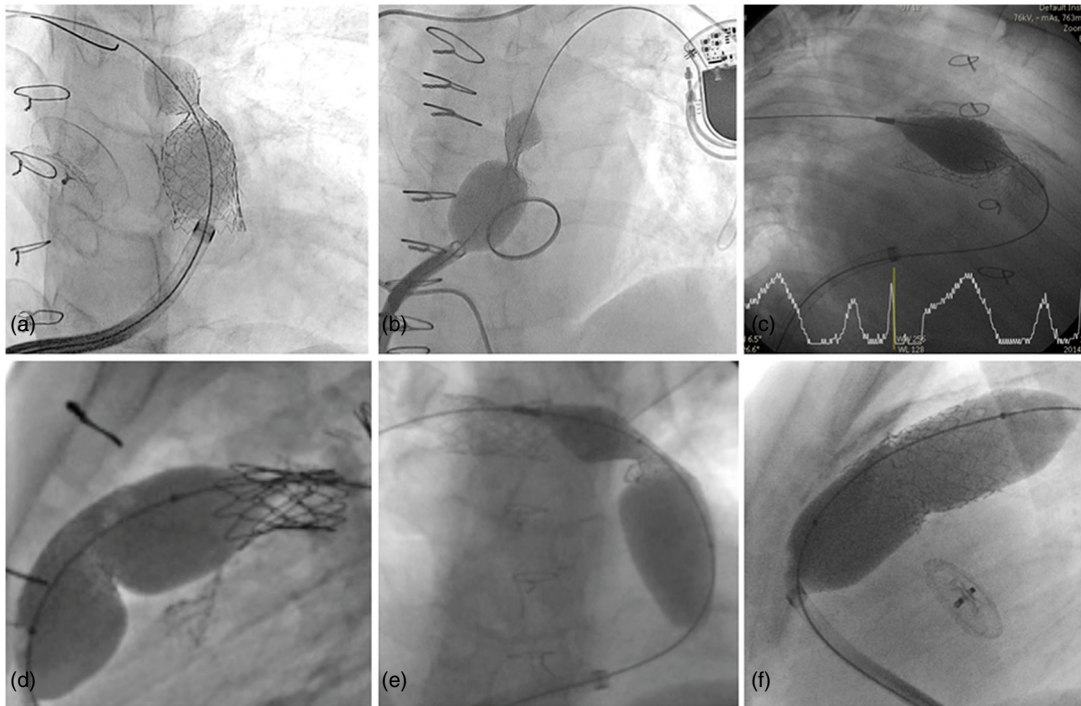
We reviewed the cardiac catheterisation laboratory books of the five centres in the time period from 2013 to 2018 and counted all stents implanted in the right ventricular outflow tract. In total we counted 292 stents implanted in the right ventricular outflow tract, 127 AndraStents® (Andramed), 75 CP-Stents® (uncovered; NuMED, Hopkinton, NY, USA), 64 covered CP-Stents® (NuMED), 11 IntraStents® (ev3 Inc.), 4 Optimus® stents (AndraTec, Koblenz, Germany), 1 Palmaz® (P4014) stent (Cordis, Milpitas, California, United States of America), 1 Palmaz Gensis XD stent (Cordis), 1 Advanta® V12 stent (Maquet, Rastatt, Germany). Of those 127 AndraStents® 6 formed a diabolo shape upon inflation of the balloon (all cases presented below, summarized in Figure 1). None of the other implanted stents showed this behaviour.

Figure 1. Summary of the misconfigured AndraStents[®] during inflation of the balloon in the RVOT. (a) attempted implantation of a 39 mm AndraStent[®] XL with a VACS III[®] balloon (Osypka, Rheinfelden, Germany) with 25 × 40 mm forming a diabolo misconfiguration of the stent and burst of the balloon; (b) attempted implantation of a 39 mm AndraStent[®] XXL with a VACS III[®] balloon (Osypka, Rheinfelden, Germany) with 25 × 40 mm forming a diabolo misconfiguration of the stent and burst of the balloon; (c) attempted implantation of a 47 mm AndraStent[®] XXL with an Altos[®] balloon (AndraTec, Koblenz, Germany) with 28 × 60 mm forming a diabolo misconfiguration of the stent and burst of the balloon; (d) attempted implantation of a 39 mm AndraStent[®] XL with a MaxiLD[®] balloon (Cordis, Milpitas, CA, USA) with 25 × 40 mm forming a diabolo misconfiguration of the stent and burst of the balloon; (e) attempted implantation of a 39 mm AndraStent[®] XXL with a MaxiLD[®] balloon (Cordis, Milpitas, CA, USA) with 25 × 40 mm forming a diabolo misconfiguration of the stent, no burst of the balloon; (f) attempted implantation of a 47 mm AndraStent[®] XXL with an angioplasty balloon (Balton) with 28 × 60 mm leaving a slight indentation of the stent, no burst of the balloon.

In all six patients reported in this article, a diabolo-shaped mal-configuration of AndraStents® occurred during pre-stenting of the right ventricular outflow tract for percutaneous pulmonary valve implantation. Misconfigured AndraStents® which remained in the right ventricular outflow tract could finally be expanded in four patients by sequential balloon dilatation. The attempt of percutaneous retrieval of a mal-configured, embolised stent led to fatal bleeding complication in one patient, and in another patient the embolised stent was surgically removed from the right ventricle.

If the balloon is not easily retrievable after a diabolo misconfiguration appears, we cannot recommend using an excess amount of force to pull the balloon out of the stent (in the presented case [patient 1] the balloon ruptured and a small fragment of the balloon could not be retrieved). Instead it seems advisable to establish a second vascular access, pass a second wire through the stent and open the stent with sequential balloon dilatation, starting with smaller high pressure, non-compliant balloons (e.g. Evercross[®], Atlas[®]). Whenever possible, this can be done at the desired implantation site of the stent. This was done successfully in the presented cases (patients 1, 3–5).
