Brief Report

Cite this article: Faccini A, Chessa M, Aljoufan M. (2018) Management of balloon rupture during a percutaneous pulmonary valve implantation procedure. *Cardiology in the Young* 28: 1168–1170. doi: 10.1017/S1047951118001051

Management of balloon rupture during a percutaneous pulmonary valve implantation procedure

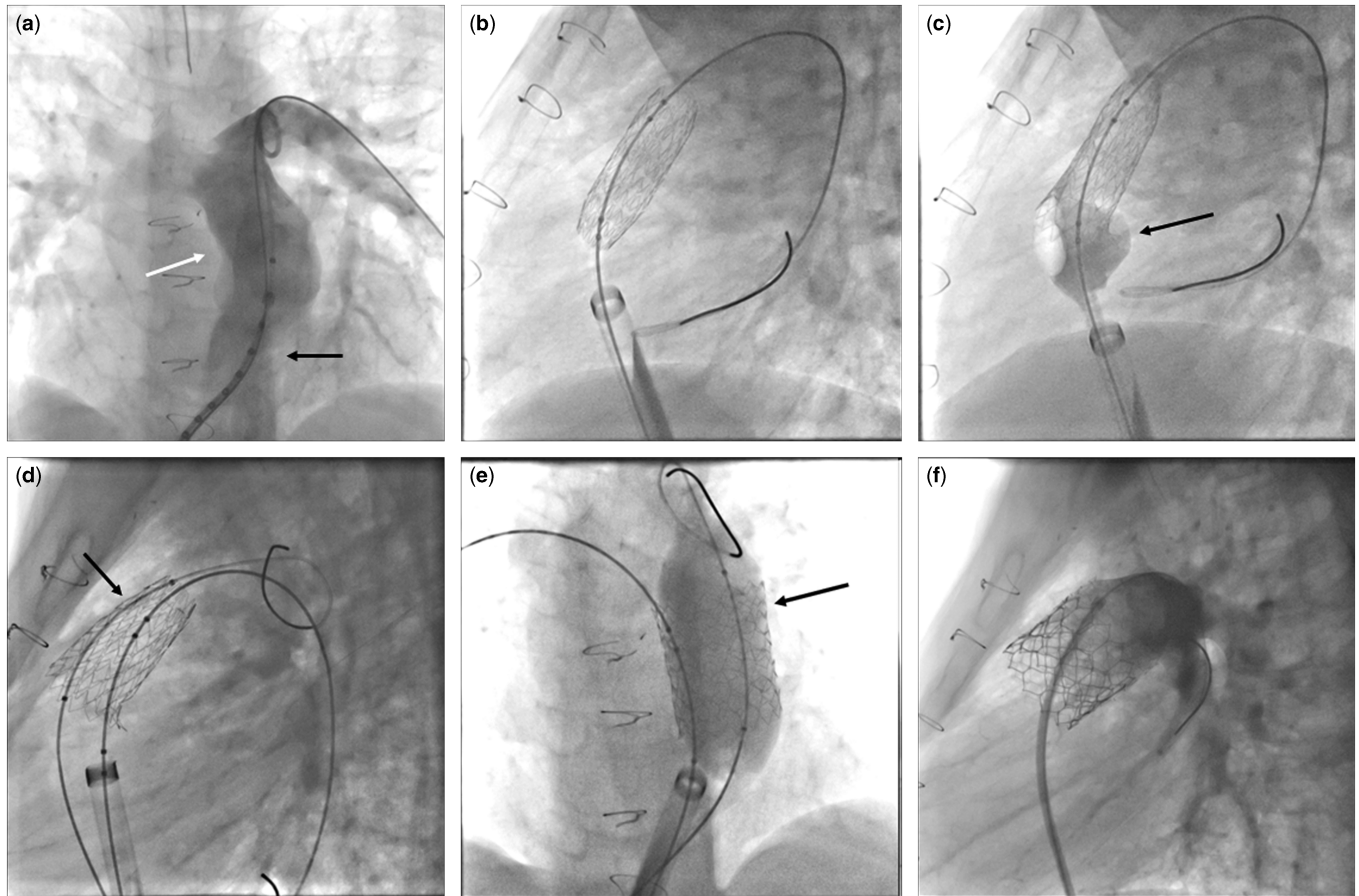
An Andra Stent XXL 43 mm (Andramed, Reutlingen, DE, Germany) mounted on a BIB balloon 30 × 40 mm was chosen to pre-stent the right ventricle outflow tract to create an adequate landing zone for the subsequent percutaneous pulmonary valve implantation. The inner balloon completely swelled (Fig 1b), whereas only the proximal part of the outer balloon expanded when it was inflated (Fig 1c, black arrow), suggesting a distal small rupture of the outer balloon itself. The BIB balloon was left in place in order to avoid stent embolisation, which was the main risk. An adjunctive venous access was gained through the left common femoral vein by inserting a 12-Fr Introducer Sheath. A guidewire 0.014” and a 4-Fr Judkins right catheter were used to cross the stent parallel to the balloon. Then, a Lunderquist guidewire was changed with the 0.014 wire (Fig 1d, black arrow) and a Z-MED balloon

Figure 1. (a) Anteroposterior pulmonary angiography showing a severe pulmonary valve regurgitation (black arrow) with a dilated pulmonary trunk (white arrow). (b) An Andra Stent XXL 43 mm mounted on a BIB balloon 30×40 mm with the inner balloon completely swelled. (c) Expansion of only the proximal part of the outer balloon (black arrow), suggesting a distal small rupture of the outer balloon itself. (d) BIB balloon left in place with a Lunderquist guidewire that crosses the stent parallel to the balloon (black arrow). (e) Z-MED balloon inflated, after BIB balloon deflation, with a complete stent expansion (black arrow). (f) A 29-mm Edward Sapien 3 implantation.

30 × 40 mm (NuMED Inc.) was advanced. The BIB balloon was completely deflated, and the Z-MED balloon was inflated up to 2.5 ATM (Fig 1e, black arrow), with a complete stent expansion without sign of dissection at the control angiography. Both balloons were then drawn back and a 29-mm Edward Sapien 3 valve was implanted, with a good final result (Fig 1f). The following inspection of the ruptured BIB balloon revealed a small hole (Fig 2a, white arrow), probably caused by a senior operator while

This case illustrates a useful approach in the case of incomplete stent expansion in the right ventricle outflow tract owing to balloon rupture. It has allowed both to fully expand the stent and to safely withdraw the ruptured balloon.

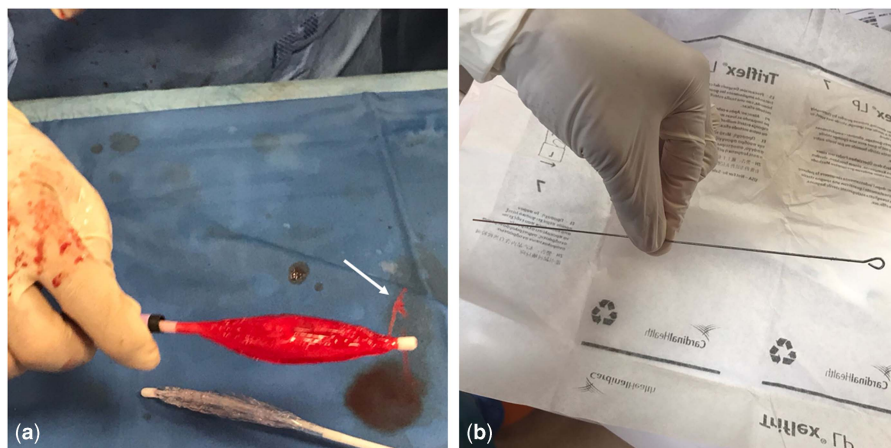
Figure 2. (a) A small hole evidenced when inflating the BIB balloon outside the patient (white arrow). (b) The spindle that caused the rupture.

re-inserting the spindle into the balloon catheter to give a higher support to the balloon when mounting the stent (Fig 2b).

Once rupture of the stent balloon occurs, the stent usually expands incompletely, and the balloon cannot be easily withdrawn. Moreover, withdrawal may be complicated by displacement of the stent off the balloon⁵ and/or damage of the tricuspid valve on the way down to the inferior caval vein. Albeit rarely, pinhole rupture of a balloon has been described to occur during catheter treatment of highly calcified coronary artery lesions, causing incomplete stent expansion. A case report delineated how this problem was overcome inflating the balloon with a higher concentration of contrast medium.⁶ In our case, the balloon defect was possibly caused by re-inserting the spindle into the balloon catheter to give a higher support to the balloon when mounting the stent or by stent edge while being crimped.
