Subdural haematoma: a complication of cochlear implantation

V. S. SUNKARANENI, B.Sc., M.R.C.S., D.O. H.N.S., A. BANERJEE*, M.S., F.R.C.S.(ED.) (ORL-HNS),
R. F. GRAY, L.R.C.P., M.R.C.S., M.A., F.R.C.S.

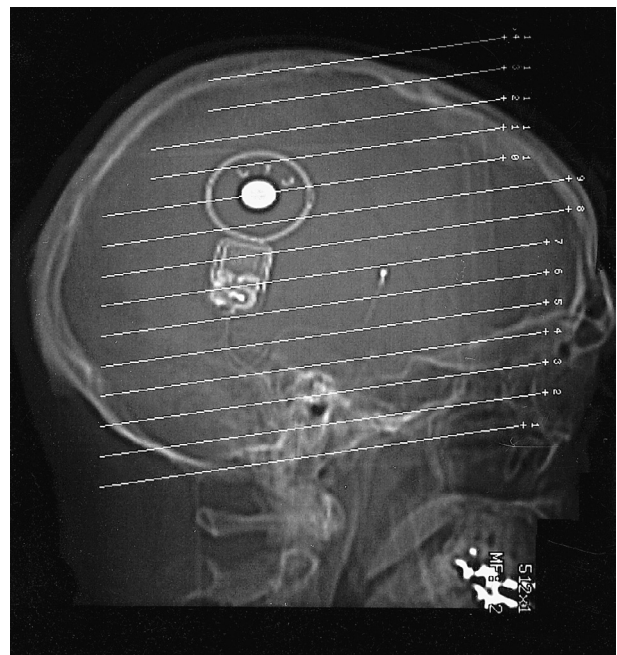
FIG. 1

The implant used was a Nucleus[®] 24 channel cochlear implant and the procedure was performed in accordance with that described in the surgeon's guide supplied with the implant; a post-auricular incision, cortical mastoidectomy, posterior tympanotomy, and cochleostomy. Having created the well for the receiver/stimulator, tie down holes were created using a 2 mm diamond paste burr drill. The package was secured in position with 3-0 Ethilon[®] ties inserted through these holes. The electrode was inserted through the cochleostomy and, after checking the neurophysiology, the wound was closed (Figure 1).

Lateral 'scannogram' showing position of receiver/stimulator.

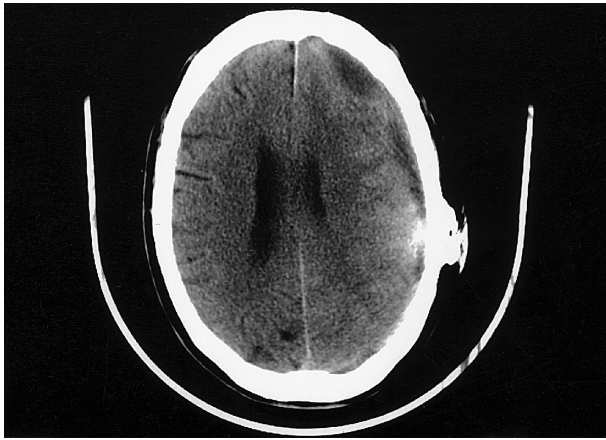
FIG. 2(A)

(CT) scan of the head revealed a minor degree of midline shift caused by a thin left-sided subdural haematoma. A repeat scan nine days later showed this to have increased in size, with a more noticeable midline shift (Figures 2(a) and 2(b)).

Axial CT scan demonstrating subdural haematoma.

In the present case, the authors feel that the cause of the subdural haematoma is likely to have been injury to an emissary vein whilst creating the 'rat bite' holes in the calvarium, or from passing the suture needle through them. There was some bleeding through these holes initially, and haemostasis was achieved using bone wax. They suspect that the bleeding, however, continued internally, and led to the formation of the haematoma.

The patient underwent drainage of the haematoma via a left frontal burr hole. This was performed under local

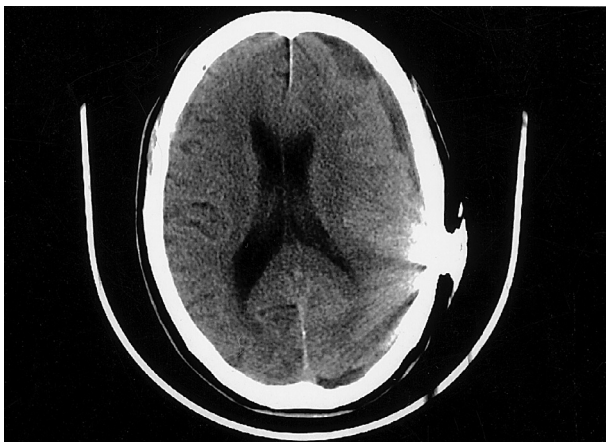
FIG. 2(B)

Midline shift of the brain caused by the subdural haematoma.

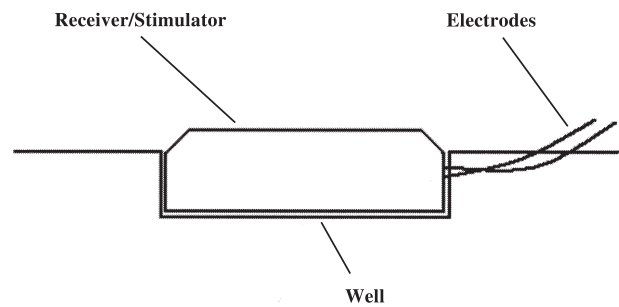
FIG. 3

Diagrammatic representation showing how implant should sit within bony well; note the square edges to the recess, obviating the need for tie-down sutures.

The authors advocate the creation of a deep well for seating the implant, with appropriately 'squared off' rims (Figure 3) which would prevent the migration of the receiver/stimulator without the need for further devices. Furthermore, this would lend itself to fewer 'foreign' bodies within the surgical site, and therefore, less chance of infection.

The authors' unit has performed 140 cochlear implants since this case. They have not used anchoring sutures in any of these, and have not had any further complications of this kind. Furthermore, none of their patients have suffered receiver migration or extrusion.
