Reburial of a mosaic floor discovered at Tocra (Taucheira)

By Ahmed Buzaian¹ and Mohamed Hashem²

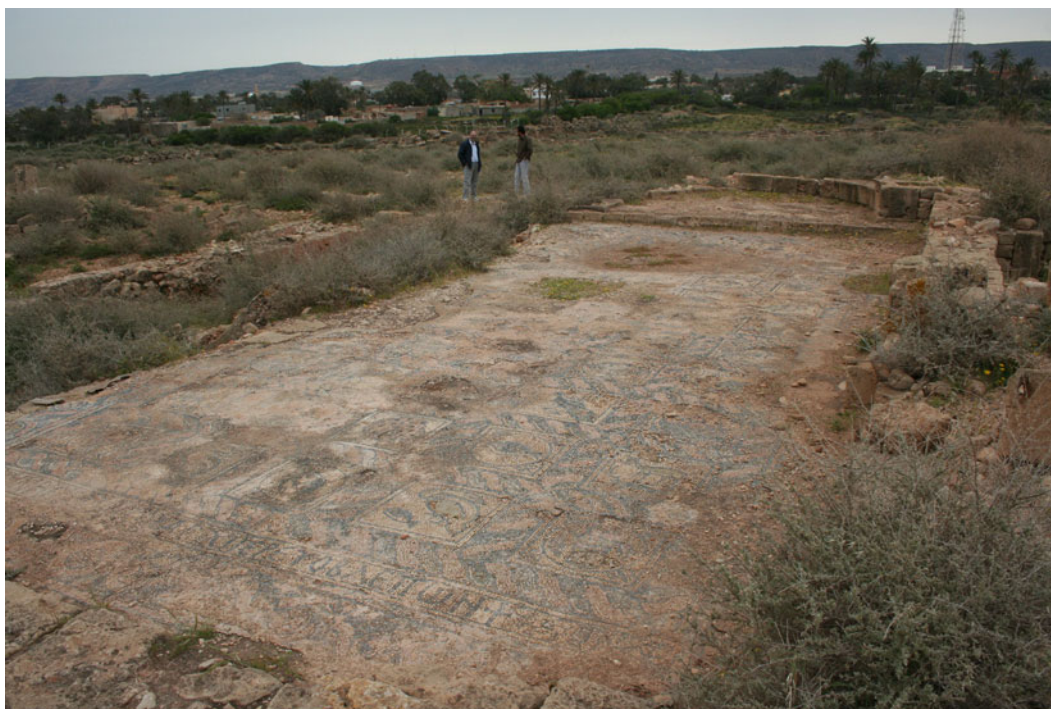
The earlier mosaic floor remained *in situ* with no provision for its protection (Fig 1). It consists of 55 approximately square panels which contain representations of birds, fish, and other animals, flowers and baskets of fruits. Each panel is framed by a two-strand guilloche (Ward-Perkins and Goodchild 2003, 218). The pavement includes two Greek inscriptions. One is contained within a panel positioned in the middle of the floor and, most likely, mentions the name of the patron. The other occupied the whole length of the northern end of the

Figure 1. The mosaic floor before restoration (photo: P. Kenrick).

The mosaic has continued to deteriorate and, until recently, there was a real risk that this process might accelerate and result in complete loss. The problems affecting the floor can be attributed to environmental and human factors. Over the course of almost 40 years, the mosaic has been exposed to extreme weather conditions with wide seasonal fluctuations which bring rain and drought, heat and cold. Plants grow across the archaeological remains, penetrating and damaging the mosaic. Salts are also common due to the site's coastal location.

Based on the circumstances cited above it was deemed necessary to rebury the mosaic in a methodical fashion appropriate to its context and needs. This idea was entirely our own and would preserve the mosaic in the short and medium term, until resources become available for its proper conservation, protection and display. In advance of the reburial we were fortunate to have the opportunity to discuss the reburial process with W. Wootton and J. Stewart, who visited Tocra in April 2012 during the evaluation trip for the *Conserving and Managing Mosaics in Libya* project (Wootton forthcoming). The mosaic did not require any critical pre-stabilisation before reburial. A small number of tesserae were detached, but the tessellatum was relatively well adhered. After consideration, discussion and consultation of the appropriate sources, the materials and processes were decided upon and these can be summarised as follows:

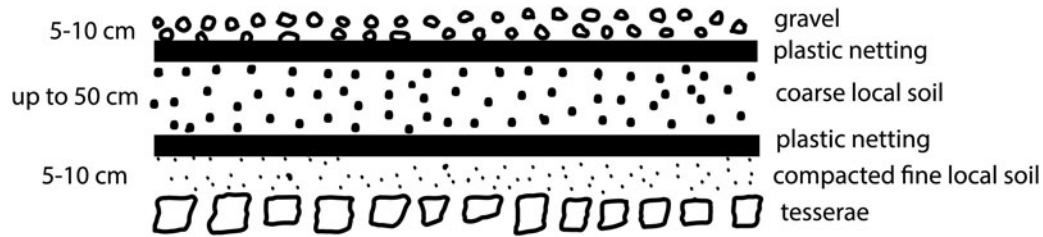
Figure 2. Diagram showing the successive stages of reburial (drawing: A. Buzaian).

4- The fill materials and layer separation markers (Fig. 2).

Sieved local soil from previous excavations inside the ancient city was used to cover the floor. The spoil heap of the ongoing training excavations of Benghazi University made an excellent and practical source. This soil was sieved, loaded into sacks and then transported to the location of the mosaic floor. It was then spread onto the mosaic's surface and into voids, forming a layer between 5 and 10 cm thick and, following laying, was well compacted (Fig. 3).

- Over this was placed a carpet of netting with a mesh size of 1.35×1.35 mm and manufactured from white polyethylene. The purpose of the plastic mesh was to indicate the presence of the delicate mosaic surface in the case of future

re-excavation (Roby 2004, fig. 6; Stewart 2004, fig. 7). This plastic netting also forms an interface between the sieved layer and the coarser soil above, and it will allow the transmission of moisture through the reburial covering.

- Unsieved soil was then laid to the height of border walls. This layer was up to 50 cm thick and well compacted;
- Another similar plastic mesh was placed above to add stability to the coarse soil below;
- Gravel was used for the upper-most layer to stabilise the soil and to prevent the growth of vegetation on the top.
- Breeze-blocks were also used to surround the paved hall. These were positioned directly on the low sills flanking the pavement on the north and south sides, without using any cement mortar.

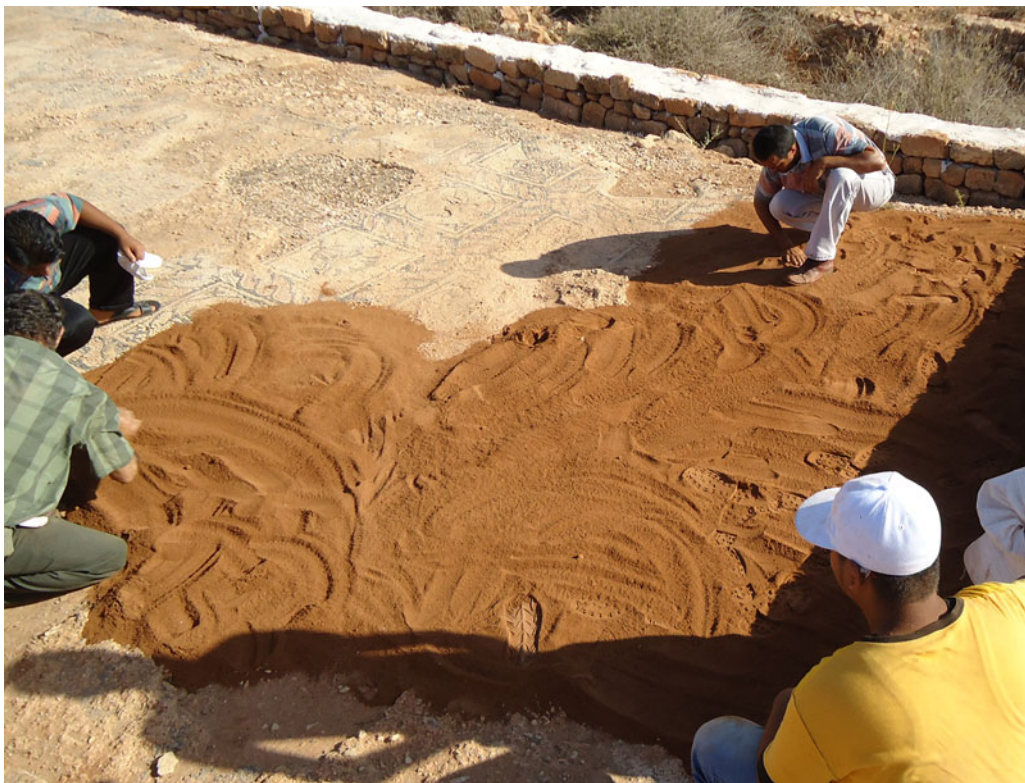
Figure 3. Covering the mosaic floor with sieved soil from previous excavations. Note the re-used stone blocks in the wall in the background (photo: A. Buzaian).
