pp 872–887. © Royal Aeronautical Society 2020
doi:10.1017/aer.2019.158

Additive metal solutions to aircraft skin corrosion

RUAG Australia
836 Mountain Highway
Bayswater, Victoria, 3153
Australia

Centre of Expertise for Structural Mechanics
Department of Mechanical and Aerospace Engineering
Monash University
Clayton, Victoria, 3800
Australia

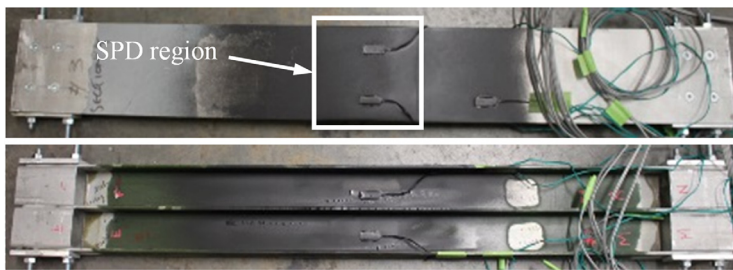
Figure 10. Specimen 3 (with SPD repair).

and 5. The strain gauges were installed on these specimens. The locations of the strain gauges on these specimens are shown in Figs. 7–11.

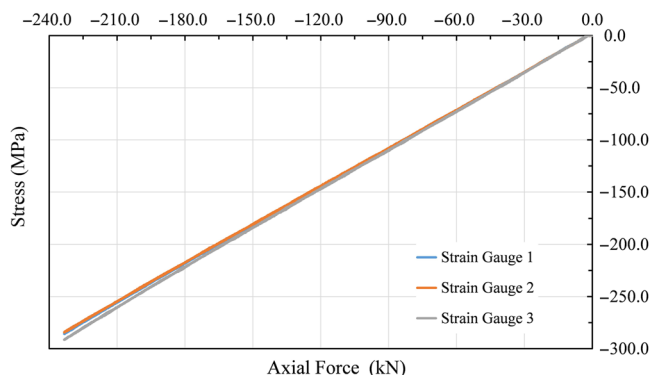
Figure 12. Comparison of the stress versus force, up to the onset of buckling, for the pristine specimen, i.e. Specimen 1.

The stress (in the skin) versus load curves associated with the pristine specimen, i.e. Specimen 1, is shown in Fig. 12. Here we see that the response was essentially linear (elastic) with load so that the specimen saw elastic buckling. We also see that Gauge 3, which was located in the centre of the specimen, has essentially the same reading as gauges 1 and 2, which are located closer to the grips. The elastic buckling associated with Specimen 1 is confirmed in Fig. 13, which shows the specimen after it has been removed from the test rig. Here we see that the specimen has essentially returned to its original shape.

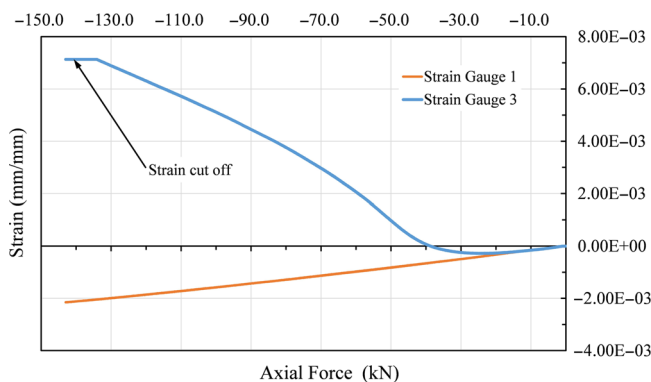
Figure 14. The strain versus force curves for simulated corrosion Specimen 2.

The strain and stress versus load curves associated with simulated corrosion Specimens 2 and 4 are presented in Figs. 14–17, respectively. Figures 14 and 16 reveal that the simulated corrosion resulted in large out of plane displacements and that, as a result, large (post-yield) strains were seen in the skin at the location of the simulated corrosion. In contrast the regions remote from the simulated corrosion remained elastic. Figures 15 and 17 reveal that under loading up to approximately -65.4kN and -67.8kN the skin is behaving linearly for Specimens 2 and 4, respectively. Once these loads have been reached, the skin in the vicinity of the simulated corrosion experiences large elastic deformations with yielding commencing at approximately -127.7kN and -116.6kN for Specimen 2 and Specimen 4, respectively. (Here it should be noted that MILHDBK 5 lists the yield stress of the 7075-T6 wing skin as approximately 480MPa .) However, since in accordance with JSSG2006⁽³⁾ yielding is not allowed at 115% design limit load, this means that the maximum load that this panel could take and still meet the requirements of JSSG2006 that there is no yielding in the wing skin is approximately 101kN . This corresponds to a remote stress, as determined from the remote strain gauges, of approximately 177MPa .

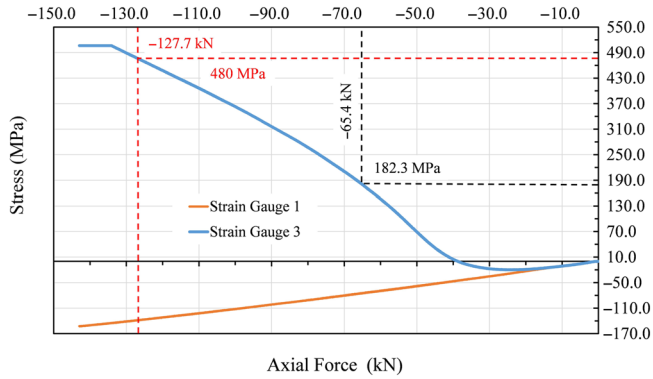
Figure 15. The stress versus force curves for simulated corrosion Specimen 2.

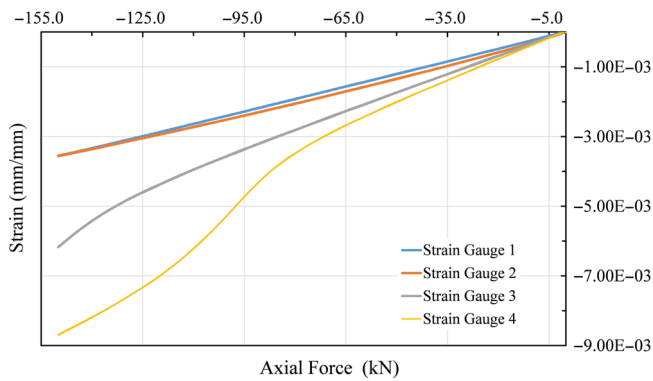
Figure 16. The strain versus force curves for simulated corrosion Specimen 4.

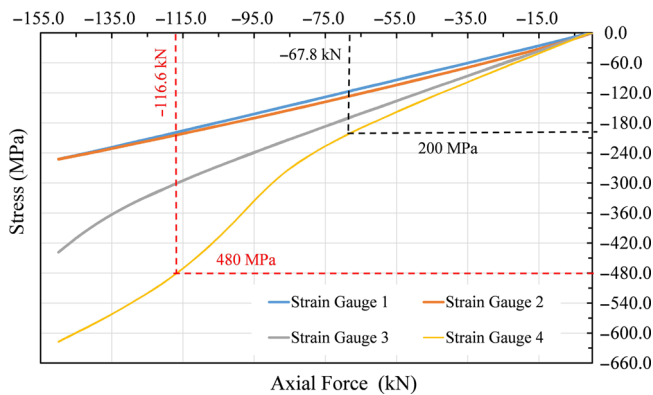
Figure 17. The stress versus force curves for simulated corrosion Specimen 4.

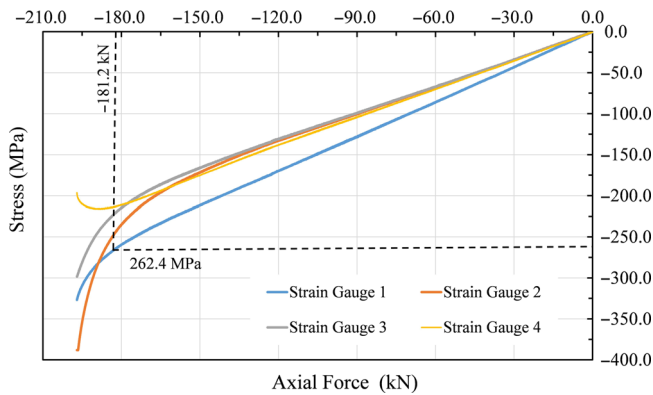
Figure 22. The stress versus force curves for Specimen 5 (with SPD repair).

–160kN, the skin is behaving linearly. After an applied load of approximately –160.0kN, the specimens began to experience a nonlinear behaviour (see Figs. 20 and 22). Photographs of the failed Specimens 3 and 5 are shown in Figs. 23 and 24, respectively. In the case of Specimen 5, the SPD restored the buckling load to that of a pristine specimen; post-buckling

resulted in both cracking and partial disbonding of the SPD. In both cases the remote stresses in the skin were measured as being above 300MPa (see Figs. 20 and 22). Given that at Design Limit Load¹ the peak stresses seen in the P3C wing skin are less than approximately 180MPa, this means that *the SPD repairs withstood proof load without failure.*

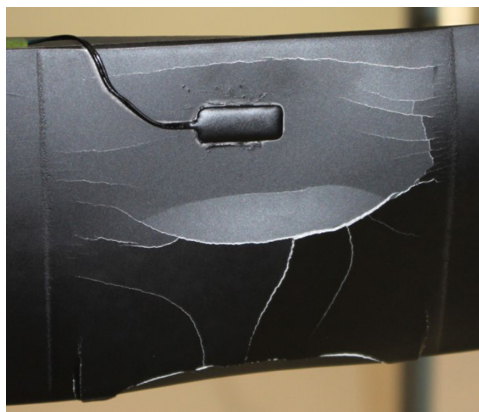
Figure 24. Specimen 5 after testing.

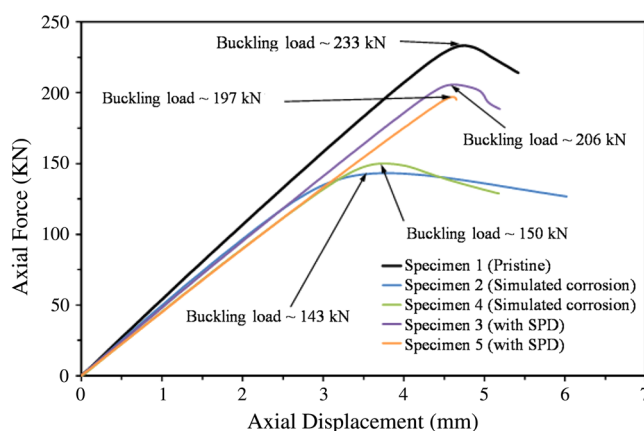
Figure 25. Load deflection and buckling loads associated with each specimen.

The resultant load deflection curves and a comparison of the buckling loads associated with the pristine specimen, specimens with simulated corrosion damage and specimens repaired using SPD is presented in Fig. 25 and in Table 2. Here it should be noted that the differences in the initial slopes of the load deflection curves is due to the differences in the specimen

geometries. For example, since the thickness of the ribs in Specimen 1 is significantly greater than that of the ribs in Specimens 3 and 5 (the SPD repaired specimens), the slopes of the load-deflection curves differ. This was confirmed by static tests on specimens prior to the machining of the simulated corrosion.

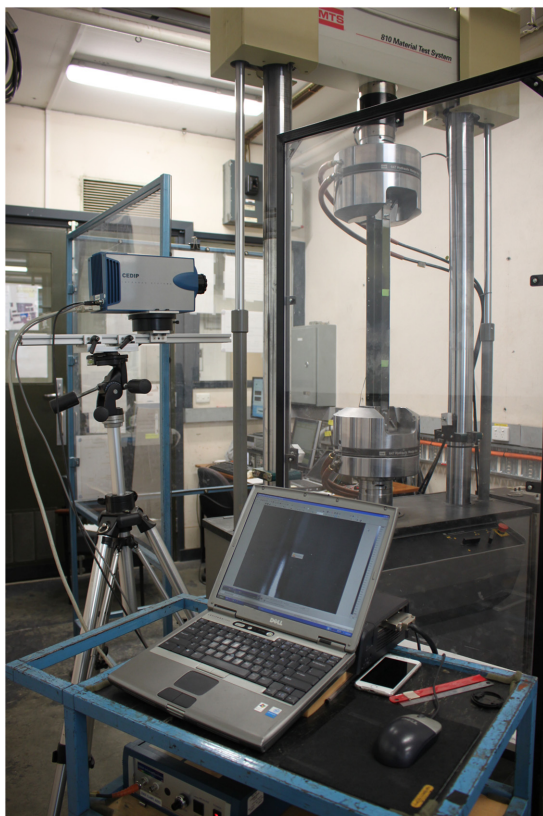
Figure 26. Specimen installed in the servo-hydraulic test machine and the infra-red camera.

Lock-in thermography was used for stress analysis of specimens, see Fig. 26.

This technology enables conducting stress analysis and estimation of fatigue limits in a nondestructive and non-contact method within a shorter period, and thus users can obtain stress maps immediately after the test⁽¹⁰⁾.
