Analysis of timber weathering and wind velocity at Cape Adare, with comments on other historic sites in Antarctica

ABSTRACT. At Cape Adare, there are three wooden historic huts in varying condition. Two are the first permanent structures erected in Antarctica for human habitation and were occupied in 1899 by the British Antarctic Expedition (1898–1900) led by C.E. Borchgrevink. The third hut was built in 1911 by the northern party of R.F. Scott's British Antarctic Expedition (1910–13) led by V.L.A. Campbell. Previous research has focused on the unusual wind regime at Ridley Beach, Cape Adare, with the use of an environmental wind tunnel to support field observations, and on the sequence of destruction by wind of the 1911 hut. The present paper focuses on the weathering of timber at some historic huts in Antarctica and presents observations and data collected on three visits to Cape Adare spanning 21 years. The results indicate that over 23% of the timber has been eroded from exposed board ends on one corner of Borchgrevink's 'stores hut' and further damage to the huts is being caused by wind blown sand and pebbles which, at two meters above the ground surface, can attain a velocit

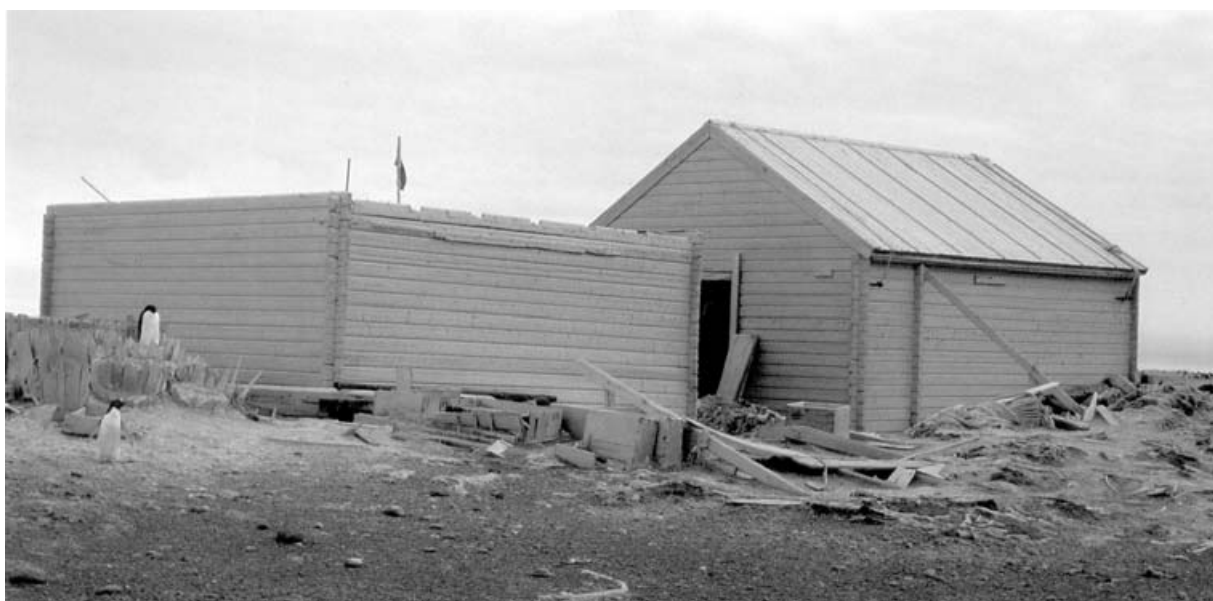
Fig. 3. Borchgrevink's huts, Cape Adare, viewed from the south east. January 1982.

Borchgrevink's equipment included two prefabricated huts of Norwegian design, made by Strømmen Trevarefabrikk near Christiania (Oslo) (Fig. 3). One was for stores and measured 5.2 m² and one was for accommodation and measured 6.4 m². Both were made from clean, mostly knot-free, tongue and grooved boards, 60–70 mm thick and 145 mm high and of 40–70 year Norwegian spruce (*Picea abies*) with a density of 368 kg/m³ for a dried sample from Cape Adare (P. Fuller, personal communication, 2005). According to M. Morrison, conservation architect, the wood used was of 'extremely good quality'.

The wall boards interlocking at the corners are tightened together by vertical steel hold-down bolts, inserted down pre-drilled holes and tightened from the bottom to provide good rigidity. The foundation beams were placed on the ground surface (Morrison 2004).

The two huts were aligned north-south and separated by an alleyway about three meters wide, which at the time of the expedition, was enclosed. On each hut the east-facing roof line was extended to ground level which over the past 106 years, has gradually built up with wind-blown pebbles and guano from nesting penguins. Today Borchgrevink's 'living hut' is in good condition although his 'stores hut', which had the roof removed in 1900, is in only fair condition.

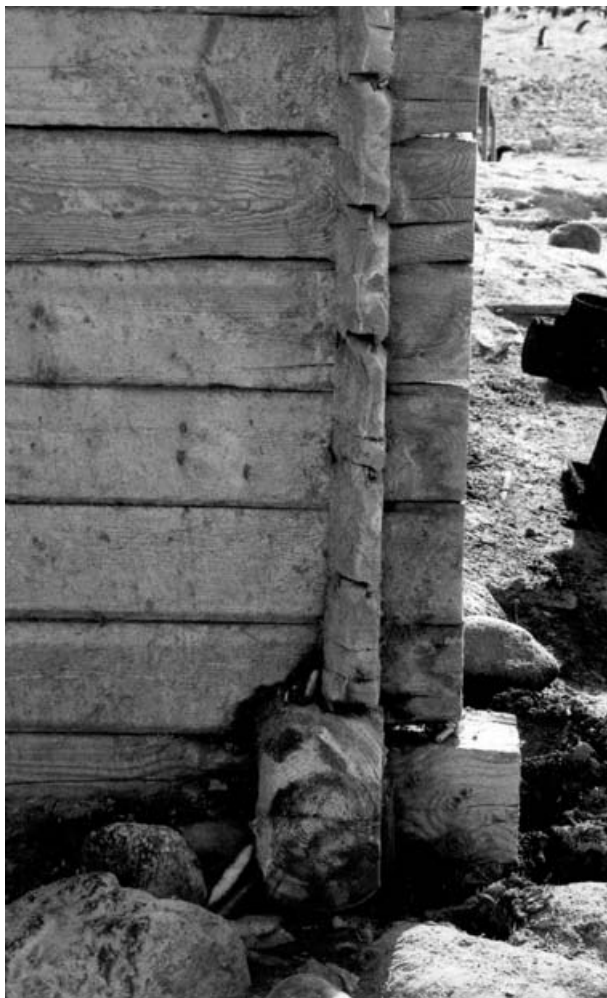
Fig. 4. Weathered northeast corner, Borchgrevink's 'stores hut' with coating of salt and sand particles. January 2003.

1. Abrasion of the soft (spring) wood in wall boards by wind-blown sand and granular particles. This is particularly evident in the protruding east-facing boards of the north wall of Borchgrevink's 'stores hut' and along the north wall in the alleyway, where abrasion of early wood is particularly noticeable at the east end (Harrowfield 1984).
2. Indentations caused by particles of granule to pebble size. Although bruising from impact of pebbles is noticeable on the east wall of both Borchgrevink huts, this is more evident on the 'stores hut' and may reflect closer proximity of particle sources or relate to ground terrain.
3. Embedding of coarse sand/small pebbles and larger angular sized particles and in some instances splitting.

Table 1. Measurements for weathering of board ends from the northeast corner of the 'stores hut'. Beginning at lower part of board, readings were taken at 2 cm intervals up the board.

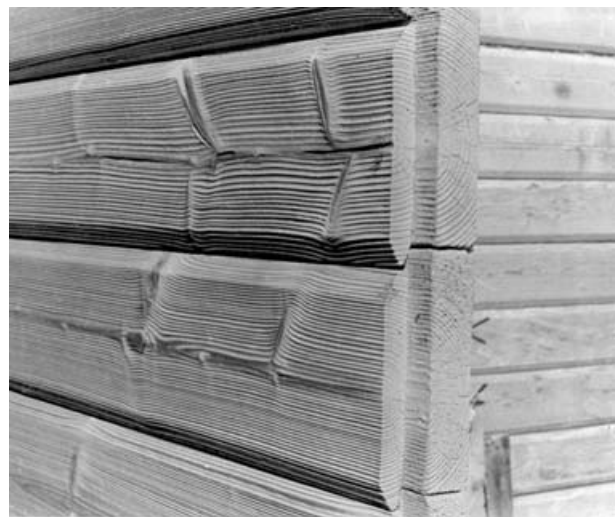
Fig. 5a. Weathered north wall boards, Borchgrevink's 'stores hut'. January 1982.

On the north wall of the stores hut, a vertical profile of weathering was also obtained using sheet dental wax softened in boiling water on a Primus stove and applied with a 'release agent' of plastic film, to prevent the wax adhering to the wood while at the same time retaining the cast and the heights at which the most severe weathering occurred, were similar to the north-east corner (Figs. 5a, 5b).

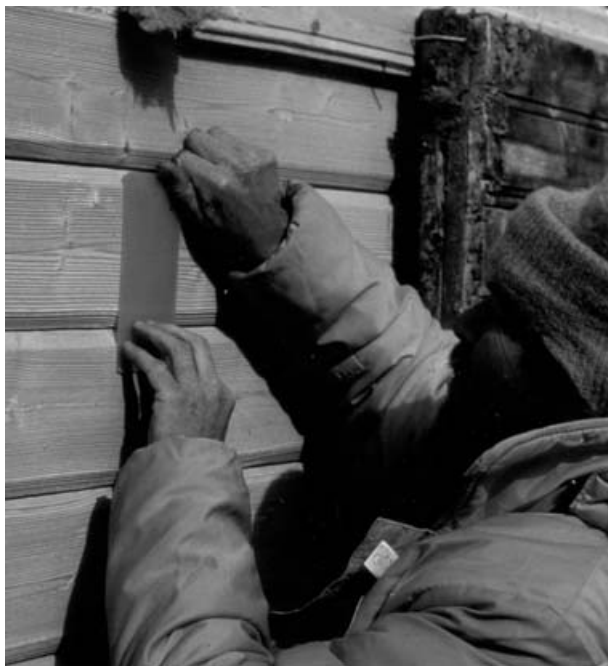
Fig. 5b. Obtaining dental wax cast from north wall boards 'stores hut'. January 1990.

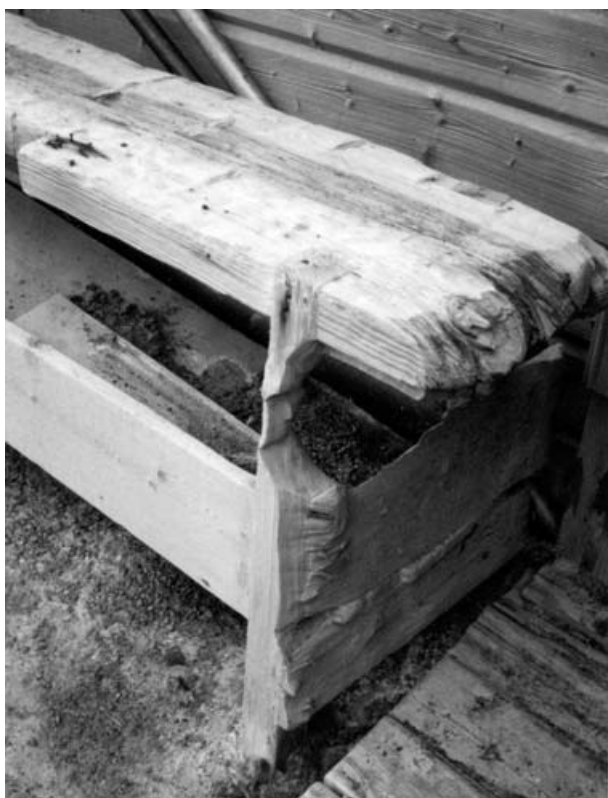
Fig. 6. Severely weathered end carpenter's work bench. January 1990.

55 × 67 mm has the 55 mm dimension now reduced at 54 cms above ground level to 19 mm. The bench top 73 cm above ground level is badly abraded at the east end (Fig. 6). This damage is probably associated with

In the alleyway, there is severe weathering to the east end of the 1899 carpenter's work bench positioned against the south wall of the 'living hut'. The maximum weathering of the most exposed bench support originally

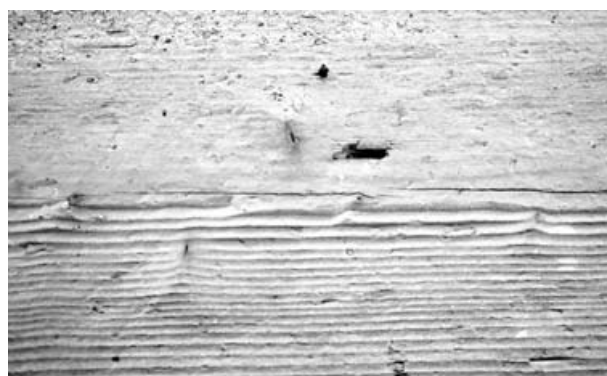
Fig. 7b. Embedded part of basalt pebble, east wall 'stores hut'. January 1982.

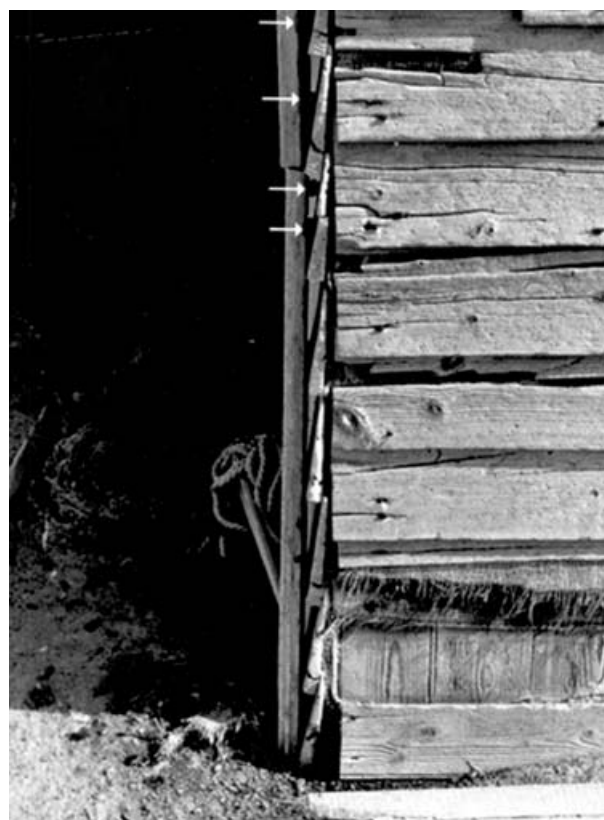
Fig. 8. Pebbles embedded between boards of porch wall 1911 hut. January 1990.

south-east corner of the cold porch and positions were recorded for height above ground level and depth of penetration (Fig. 8). The particles were likely to have originated from the penguin nesting areas east of the hut.

Of 32 particles extracted (Table 3), with exception of three pebbles, all were fractured as a result of collision probably during wave action, rather than by saltation, under which process as velocity increases, particles move short distances with a jerky movement. Broken particles found within the unroofed 'stores hut' had probably been broken by high energy wave activity. Only one pebble appeared to have been recently broken and two had some polishing, perhaps indicative of having been embedded for

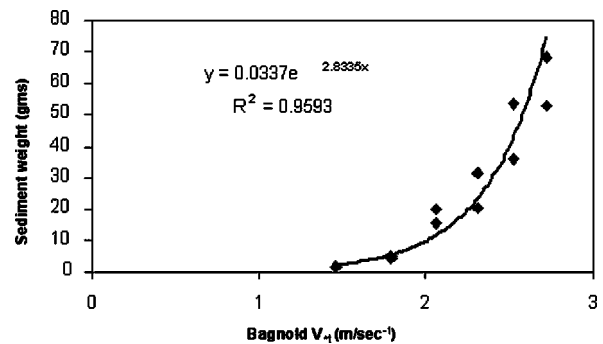
Fig. 10. Predicted velocities for particles at threshold velocity with weight 0–80 gms.

velocity, there is a greater chance for a given particle to be suspended in the airflow (Fig. 10). However, as height above substrate increases, sediment transport is likely to diminish and this is especially so when particle weight increases (Fig. 11).

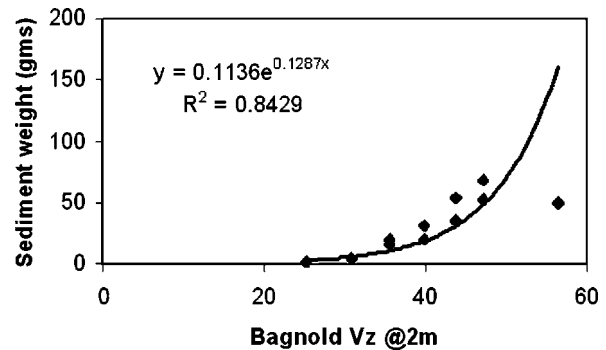
Fig. 11. Predicted velocities for particles above threshold velocity with weight 0–200 gms.

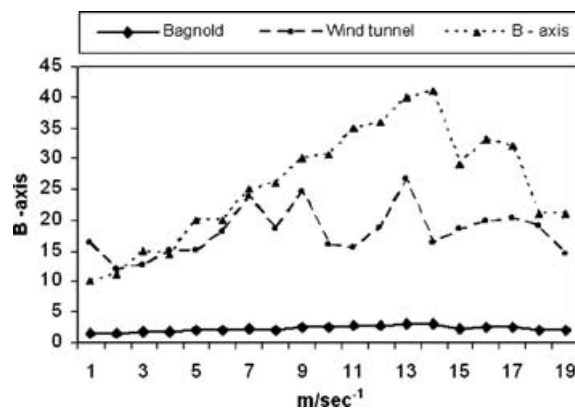
Fig. 12. Comparison of Bagnold predicted velocities with wind tunnel and B-axis of particles tested.

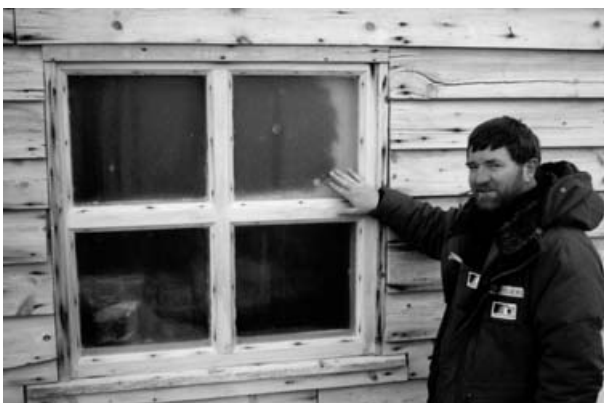
Fig. 13. Abraded glass of window on southeast wall, Scott's hut Cape Evans. January 1998.

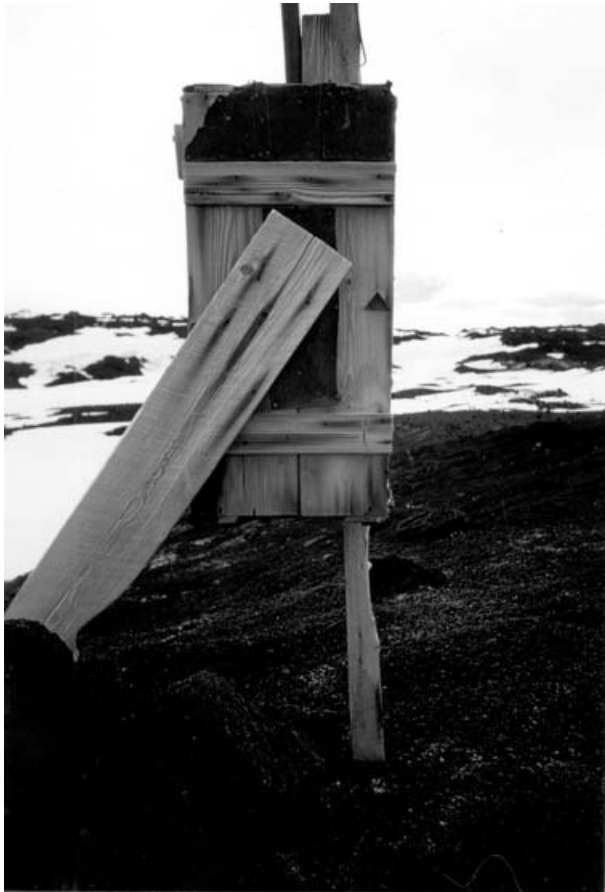
Fig. 14. Weathered instrument housing and support instrument stand, Wind Vane Hill, Cape Evans. January 2004.

Changes in thickness for one side of the support were measured with a vernier calliper each centimetre from the top in the 2001–02, 2002–03, and 2003–04 summer seasons. The most significant loss of timber is 20 cm above ground level, this coinciding with the steeper down-slope angle. Severe weathering of 34 mm, 13 cm below the top has occurred over three years with a total loss of 39 mm since 1911 when the instrument housing was installed. This suggests that weathering has increased dramatically in recent years and is confirmed with the condition of the hut corner and meteorological screen photographed in 1977.
