Stone Sculpture Wear: Alteration/Fragmentation Processes and Their Impact on Carving Traces of Tenon Heads of Chavín de Huántar, Peru

Andrea González-Ramírez

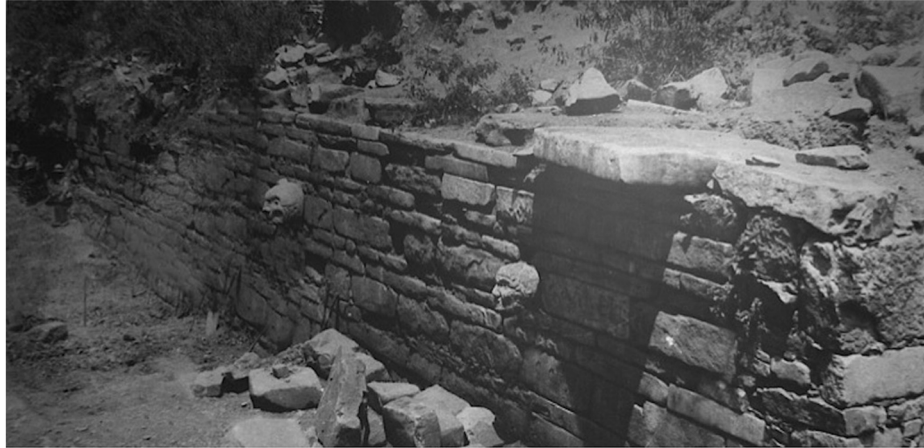
FIGURE 1. Tenon heads of the southwest corner of Building A, before a mudslide in 1945 removed the one on the right. The head on the left is still in situ (photograph from the Tello Archive, Museo nacional de Arqueología, Antropología e Historia del Perú).

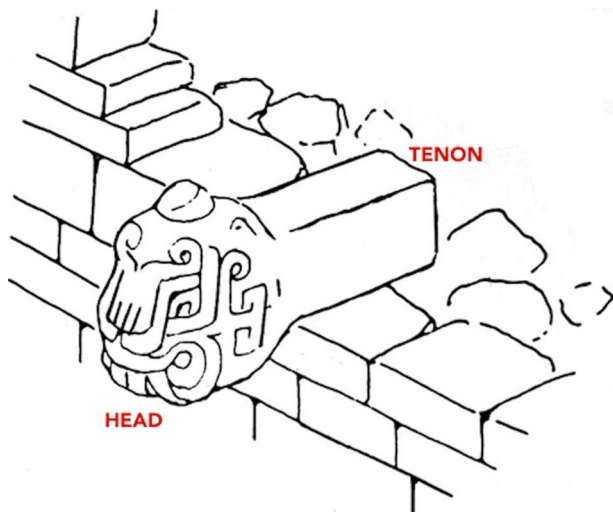
FIGURE 2. Illustration of the architectural insertion of a tenon head (drawing by W. Diessl, taken from Kauffmann 1993: Figure 30).

The loss of portions of the tenon heads is strongly manifested in the fracture of the tenon, which appears to be conditioned by the geometry and architectural use (Figure 2). This pattern of loss was the reason the evaluation of the degree of wear and the analysis of production were performed on the head and tenon separately, with the objective of increasing the sample size (González-Ramírez 2014).

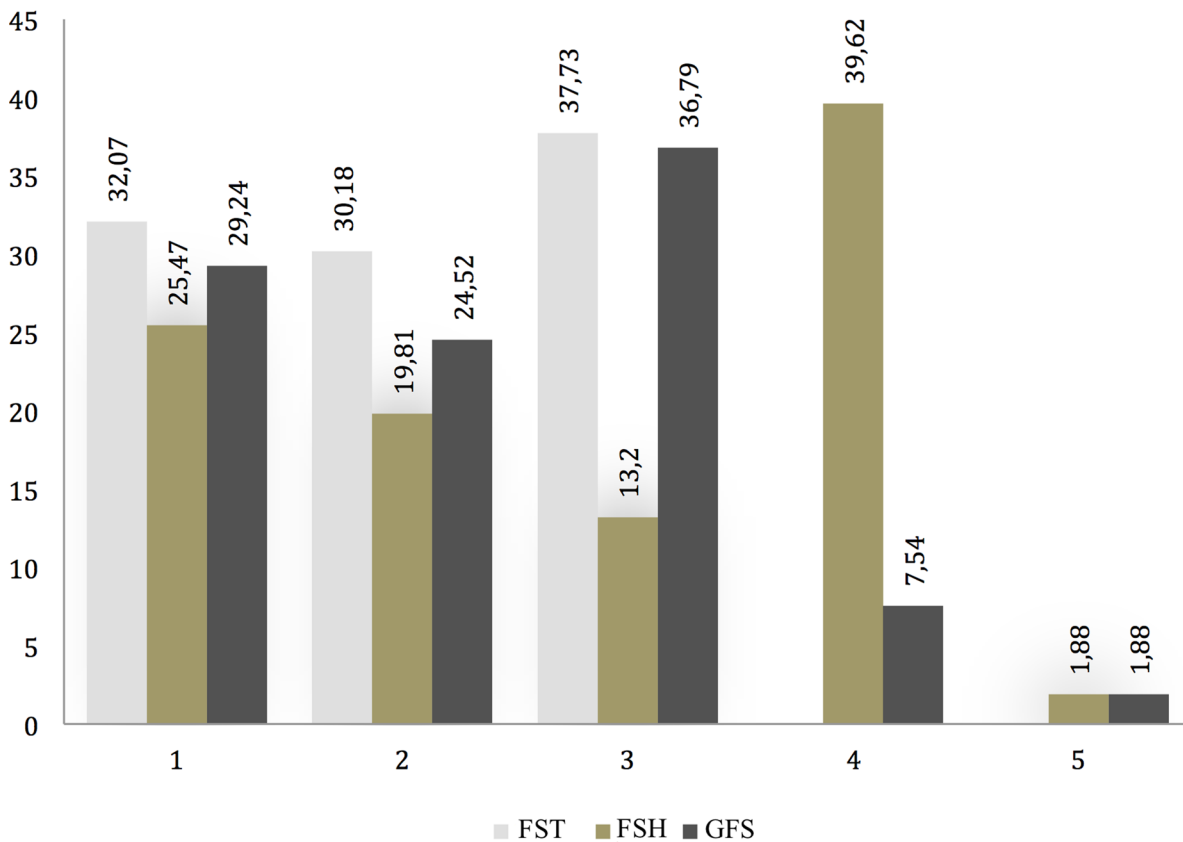
FIGURE 3. Relative frequencies in the fragmentation state diagnosis of the Chavín collection tenon heads. GSF: general state of fragmentation; FSH: fragmentation state of the head; FST: fragmentation state of the tenon.

The above is valid for sculptures that conserve the head or have transverse fractures, but a considerable number with this type of fracture may have experienced further deterioration by being dragged or by weathering in a cycle of Erosion→hair cracks→biocolonization→fracture, which may have stimulated the deformation of the outline and the loss of sculpture details. An example of these cycles is shown in the GFS and FSH with the value 4 (Table 1; Figure 3).

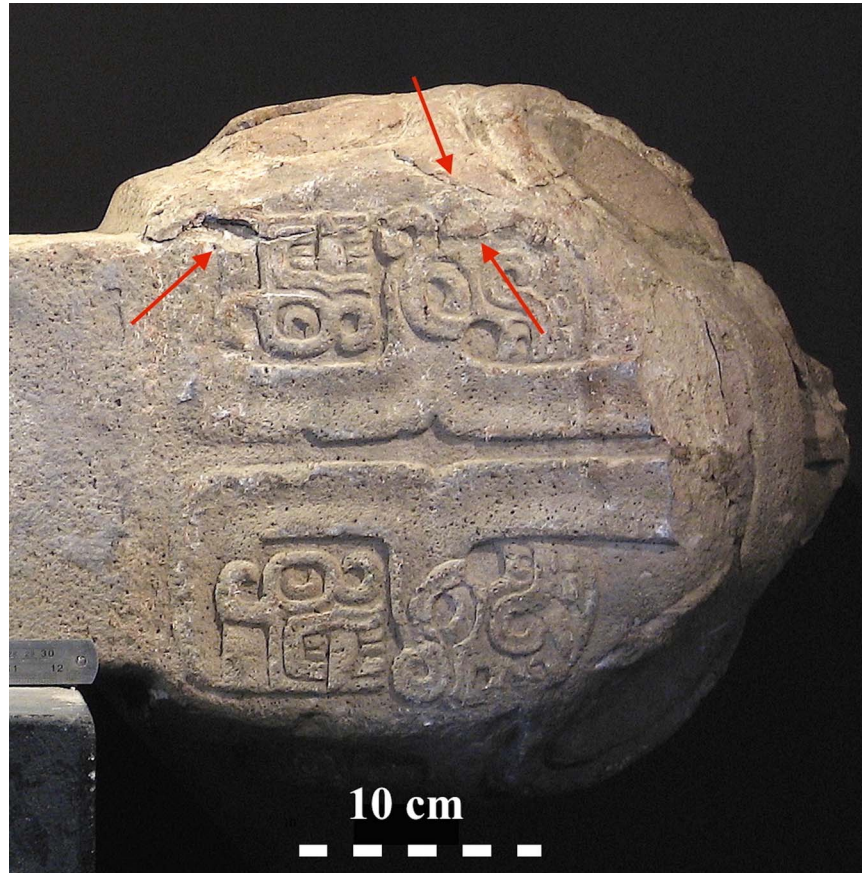
Fissures and Deformation. Three types of fissures were detected, usually located in the polished surfaces, with a frequency of hair cracks of 95%. This alteration was only observed in the heads, since the tenons showed a characteristic pecking (like a bush hammer trace) that apparently minimized their proliferation. Other factors must have acted on them that could modify the carving traces (i.e., fractures, crumbling, biological colonization), thus the presence of alterations does not guarantee that work traces will become invisible (Figure 4).⁹ Seventy-four percent of the sample showed some type of fracture, from the loss of a sculptural detail to the structural destruction of one or both portions. This obviously generated the total loss of any carving traces. A third of the sample showed splitting. This involves a weakened plane that favors the detachment of material at a right angle. Depending on the area involved, it has the same consequences as a fracture.

FIGURE 4. Hair cracks and cracks in ID16. It can be seen how the hair cracks (right to left) produce the detachment of polished cortex.

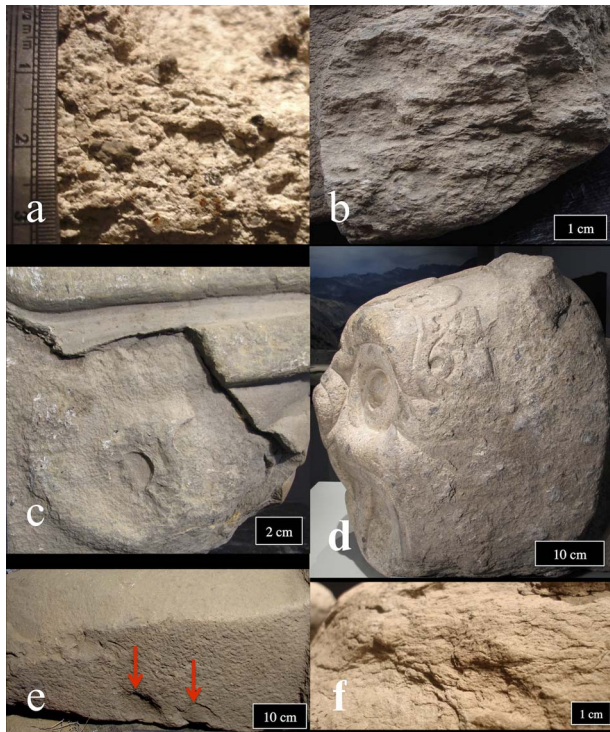
FIGURE 5. Alterations in the detachment family: (a) crumbling (87.7%), ID02; (b) splintering (82.0%), ID62; (c) contour scaling (29.2%), ID31; (d) sanding (72.6%), ID05; (e) chipping (29.2%), ID31; (f) flaking (42.4%), ID11.

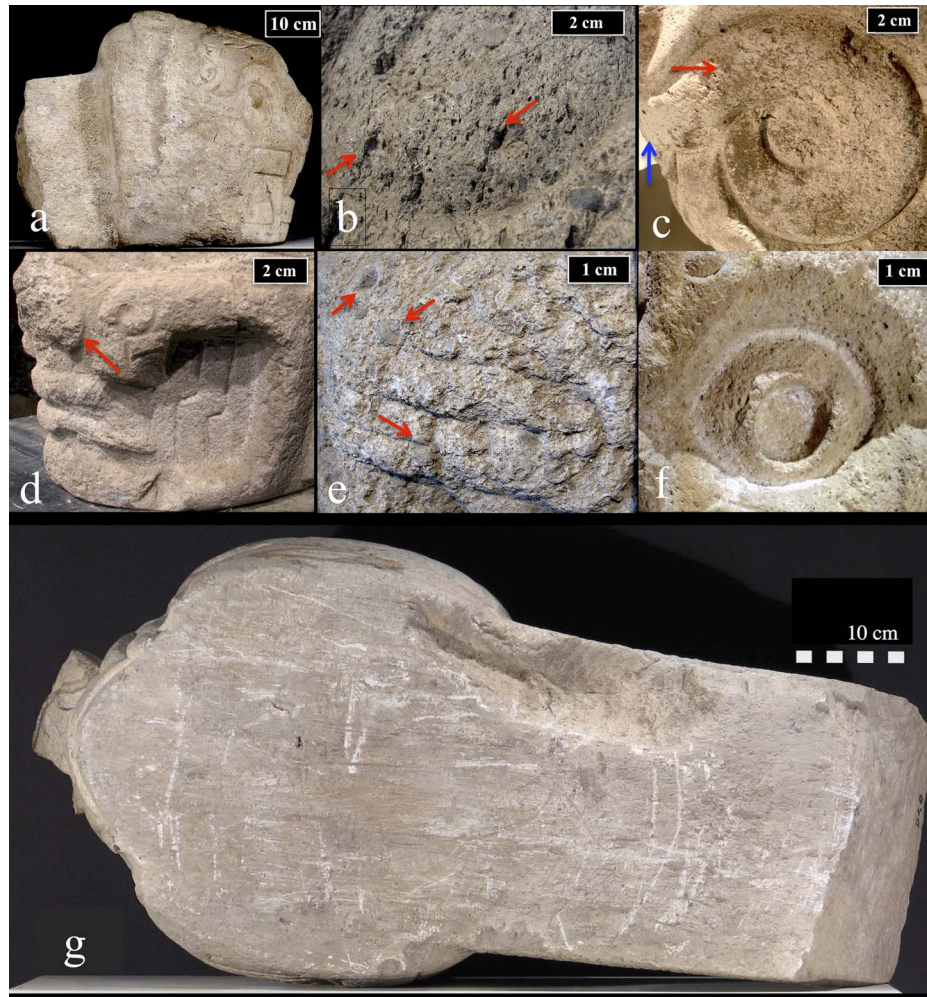
Loss of Material. The most frequent occurrence of loss of material was caused by differential erosion (91.5%; Figure 6a), which describes the unequal effects of weather agents. Loss of components, roughening, and loss of parts were found in 82.1% of the pieces (Figure 6b–d). The first describes the tendency for the loss of grains of matrix; the second, an increase in the texturizing of the polished surface; and the third, the loss of sculptural details such as noses or upper ears. Other important factors were loss of matrix (71.7%), pitting (67.0%), and scratches (60.4%; Figure 6e–g). The first is the loss of coherence in the cement of the rocks that

FIGURE 6. Illustration of characteristics produced by loss of material: (a) differential erosion (91.5%), ID05. (b) loss of components (82.1%), ID93—arrows indicate loss of microliths, which are components of the tuff; (c) roughening (82.1%), ID02—blue arrow indicates polished surface finish, red indicates increase in roughness; (d) loss of parts (82.1%), ID27—nose and left part of the mouth; (e) loss of matrix (71.7%), ID36—arrows indicate exposure of microliths due to the detachment of matrix; (f) pitting (67.0%), ID06; (g) scratches (60.4%), ID03—note the fresh marks and longitudinal grooves on the sculpture, revealing directionality (dragging).

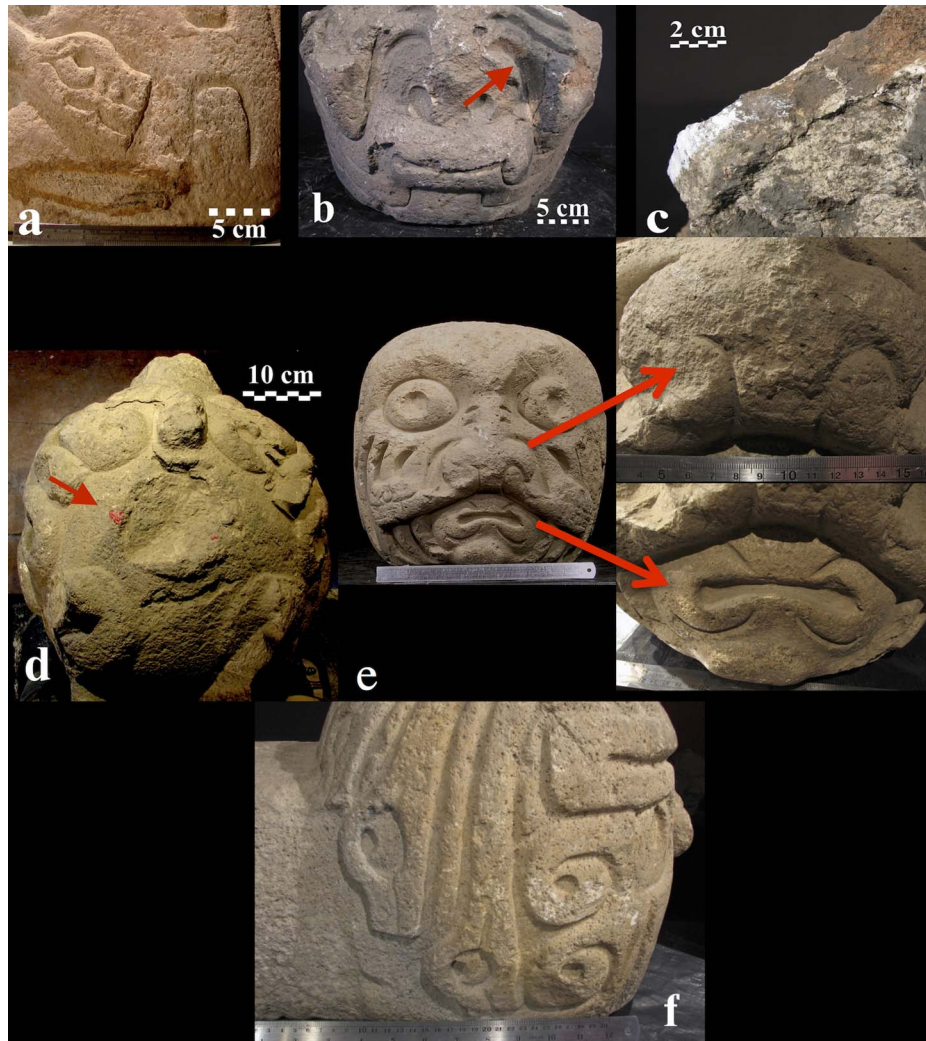
under hair cracks and appear inactive. These are salt crystals caused by water evaporation that transfers salts from the porous structure of the rock to subsurface sectors such as hair cracks or flaked areas (Figure 7c). Deposits (32.1%) were manifested in recent paint splashes and adhered dust (Figure 7d). Coloration (32.2%), black crust (24.5%), and bleaching (21.7%) were observed as chromatic modifications that altered one or several parameters of the surface color (tone, luminosity, and saturation); coloration alters the tone, bleaching increases the luminosity (probably due to a chemical alteration of the surface minerals), and black crusts are easily confused with the patinas of cyanobacteria (Figure 7b–c, f).

FIGURE 7. Examples of discoloration and deposits: (a) staining (75.5%), ID03—unknown origin; (b) oxalate patina (46.2%), ID76—red arrow indicates the presence of black crust; (c) iron-rich patina (21.7%), subfluorescences (38.7%), and black crust (24.5%), ID76; (d) deposit (32.1%) of red paint splash, ID16; (e) glossy aspect, ID79—alteration produced in the polished surface as on the previous crumbling of the nose; (f) coloration (30.2%), ID10—piece shows a modification of the tonal parameters on the right side of the face, yellower than the original ash conserved in the tenon.

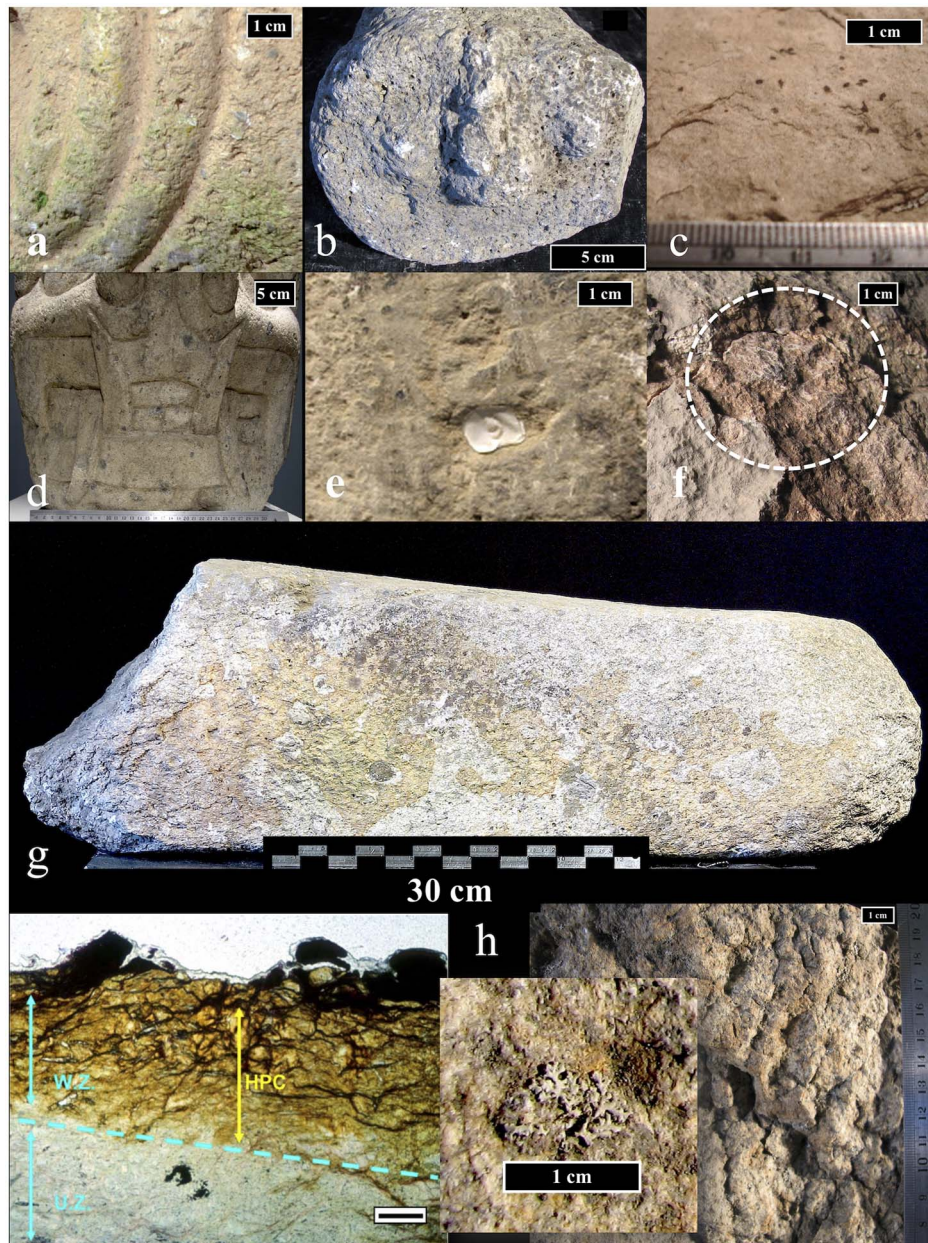
Biological Colonization. The series showed an important incidence of biological colonization, represented by algae (41.5%), lichens (44.3%), and biofilm (Hu et al. 2013; Figure 8). The management of the collection in more stable conditions during its time in museums (González-Ramírez 2014; Lumbreras and Gonzales 2012) may have stopped most of the biological colonization. Cleaning may have removed some biological remains, which are symptomatic in possibly biogenic alterations (Figure 8h). Due to this, the observed biocolonization may underestimate its real importance.

FIGURE 8. Illustration of different forms of biological colonization: (a) green algae, ID23; (b) patches of cyanobacteria (blue-green algae), ID55; (c) structures of black lichens, genus *Porina* or *Celotheilium*, ID11; (d) black patches of cyanobacteria, ID05; (e) conserved structure of white lichen (44.3%), ID27; (f) root remains, possibly lichens, ID18; (g) polychromy produced by biofilm, ID88 (this tenon was in the open air south of Building F until 2004); (h) biodeterioration of lichen origin—left: longitudinal cut of thin section of serpentine, in the inferior portion of the original structure of the rock (U.Z. = unweathered zone); top: area affected (HPC) by roots of the lichen *Lecideaatro brunnea* (W.Z. = weathered zone; from Favero-Longo et al. 2005:Figure 8); right: super-macro of ID89 with increasing agent, possibly a lichen of the genus *Heterodermia*.

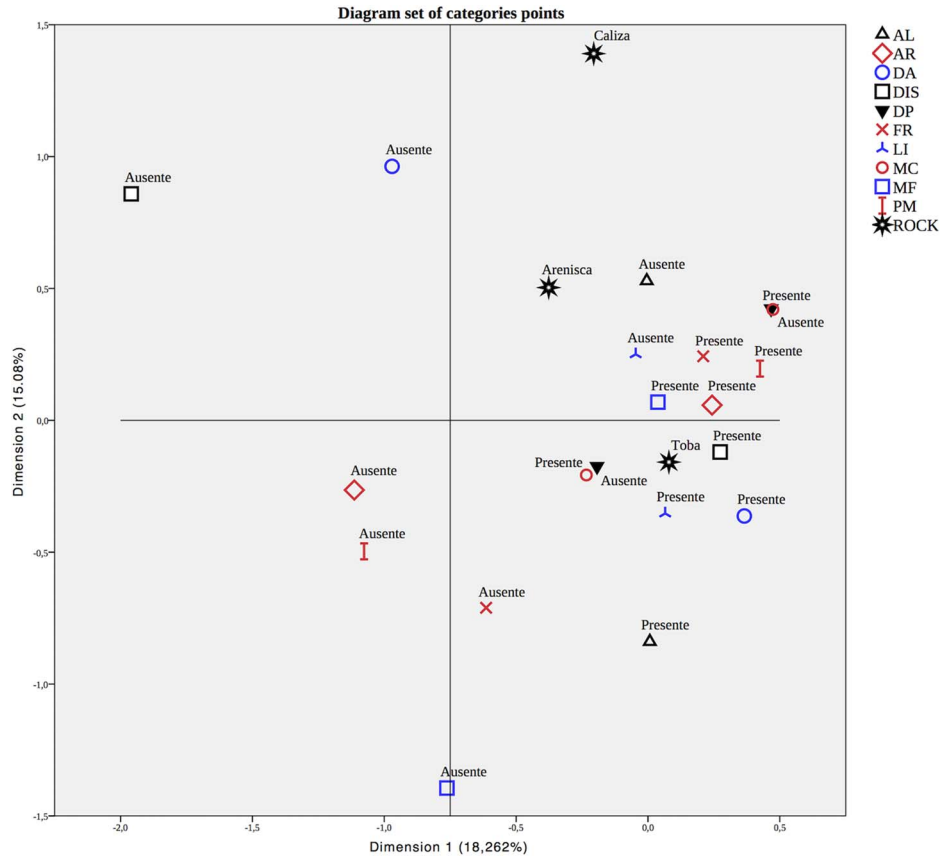
FIGURE 9. Diagram set of category points of alterations with the highest discrimination scores in the multiple correspondence analysis (SPSS 20), including the variable “rock” (*arenisca* = sandstone; *toba* = tuff; *caliza* = limestone). The scatter plot represents the score obtained for each category of variable (present/absent) in the two main dimensions of optimal scaling. The first two dimensions in the analysis represent the first and most important solutions for reducing variability, but not the only ones, hence the sum of both dimensions is not 100%. To read the graph it must be considered that the distance expresses relations of association between the categories of the variables. The abbreviations can be found in Table 4. *Ausente* = absent; *presente* = present.
