Images in Congenital Cardiac Disease

Cite this article: Ootaki Y, Ross GA, and Zeller KA (2020) An intra-aortic guide wire: what “knot” to do. *Cardiology in the Young* 30: 273–274. doi: [10.1017/S1047951119002907](https://doi.org/10.1017/S1047951119002907)

We report a rare complication of central venous catheter placement in a 5-month-old baby.

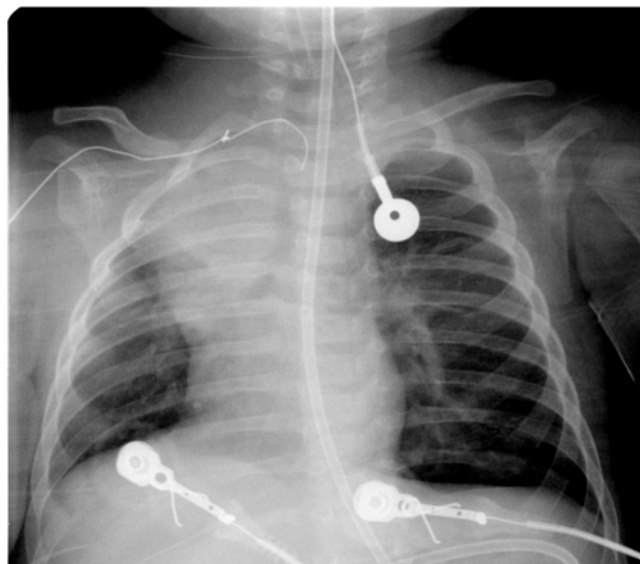
A 5-month-old baby was referred to our hospital due to status epilepticus with hemispherectomy. He was intubated due to increasing seizure activity. Placement of a central venous line via a right subclavian approach was attempted using the landmark technique. Following insertion of the guide wire, we attempted to advance a catheter over the guide wire. The catheter was unable to be advanced due to resistance and was removed. We encountered difficulty removing the guide wire, reluctant to use excessive force due to the risk of tearing the vessel. A bedside X-ray showed a kinked or knotted guide wire at the level of the right clavicular head and interval collapse of the right upper lobe (Fig 1). Hence, it was decided to remove the guide wire surgically as well as place a secure central venous line.

Figure 1. A bedside chest X-ray.

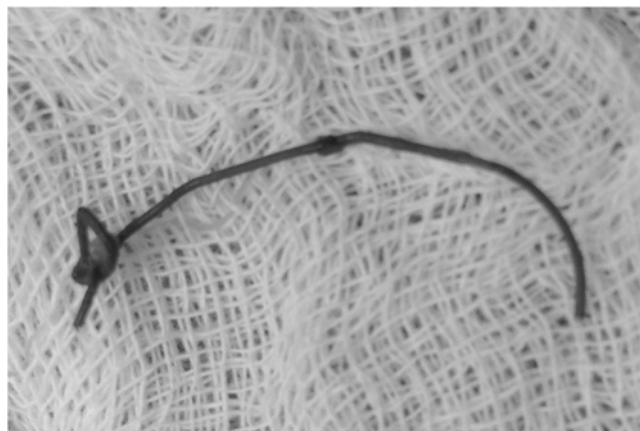
Figure 2. Removed guide wire.

found to have passed through the subclavian vein just distal to its confluence with the jugular vein. It exited the back wall of the subclavian vein and entered the innominate artery. A venotomy and arteriotomy were required to extract the guide wire from the vessels without significant bleeding (Fig 2). The patient underwent hemispherectomy on day 2 and went home on day 19 postoperatively.

A Broviac catheter was inserted into the left subclavian vein under fluoroscopy before exploration of the right subclavian guide wire. Through a subclavicular incision, the guide wire was
