The fortification of Angkor Wat

David Brotherson*

Keywords: Southeast Asia, Cambodia, Angkor, defence, fortification, construction techniques

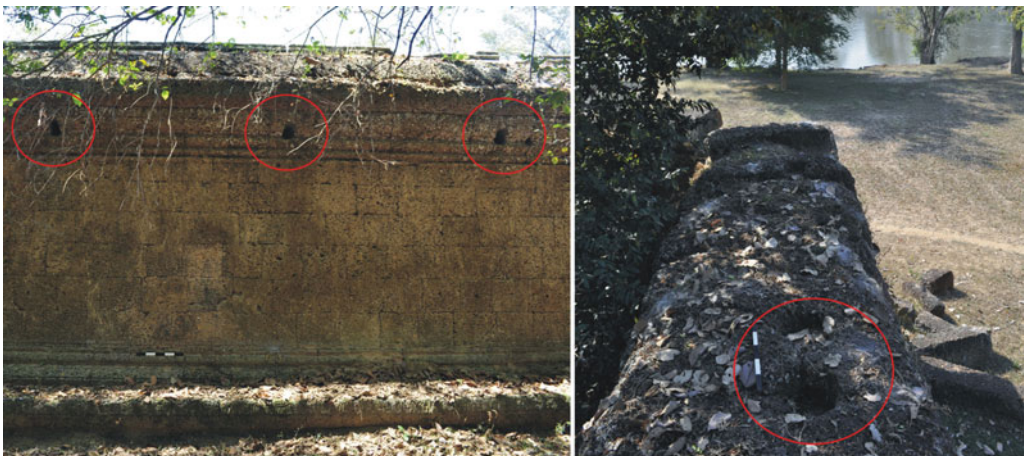
Figure 2. The fourth enclosure wall of Angkor Wat showing the horizontal holes on the inside face (left) and vertical holes along the top (right).

During the Angkorian period (ninth to fifteenth centuries), Angkor was situated at the heart of its empire but by the Middle Period or post-Angkorian period (fifteenth to nineteenth centuries), this location had come to be on the periphery of the Cambodian state. The kingdom of Ayutthaya was, at this time, expanding its influence and significantly encroaching on the former territory of Angkor. Meanwhile, Angkor Wat, originally built as a temple dedicated to Vishnu, had, by the sixteenth century, become hallowed by Theravada Buddhist monks as the religious practices of the Khmer changed. Over the centuries, Angkor Wat has undergone repairs; in addition to maintenance, it has been modified in several places, especially within the first (innermost) enclosure. These additions are significant because they reveal changes to the function of the monument. The fourth (outermost) enclosure wall also bears traces of a significant, and late, change in its function in the form of numerous holes and postholes (Figure 2), which supported substantial wooden structures that no longer

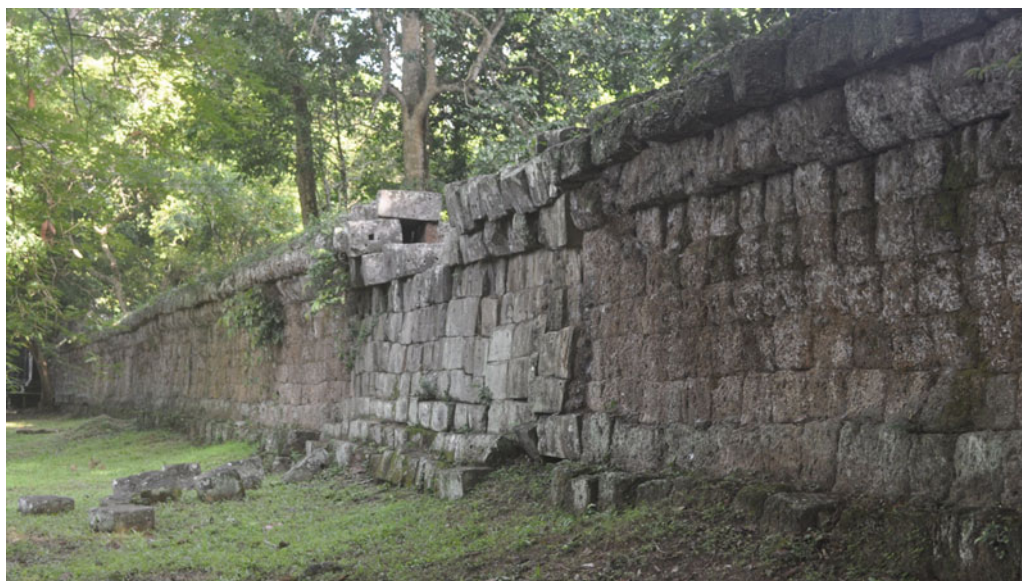
Figure 4. Gateway gap on the south wall, east side, exterior.

The nature of the masonry used to fill the gateway gaps is significant and distinct. Even though the rest of the wall was built almost exclusively in laterite, the gateway blockages make extensive use of sandstone (Figures 4 & S1–S6); moreover, some of these blocks have been recycled, featuring decorative carvings such as a dancing *apsara* (celestial nymph) and lotus motifs. It should also be noted that the windows of the South Gopura are filled by decorated blocks. The exact source of these blocks is not yet known, but the decoration on some of them resembles the style of later Bayon-era monuments. In August 2013, the author conducted a preliminary test excavation and targeted programme of coring, which focused on the substrata of the gateway gap in the north half of the east wall. The study identified

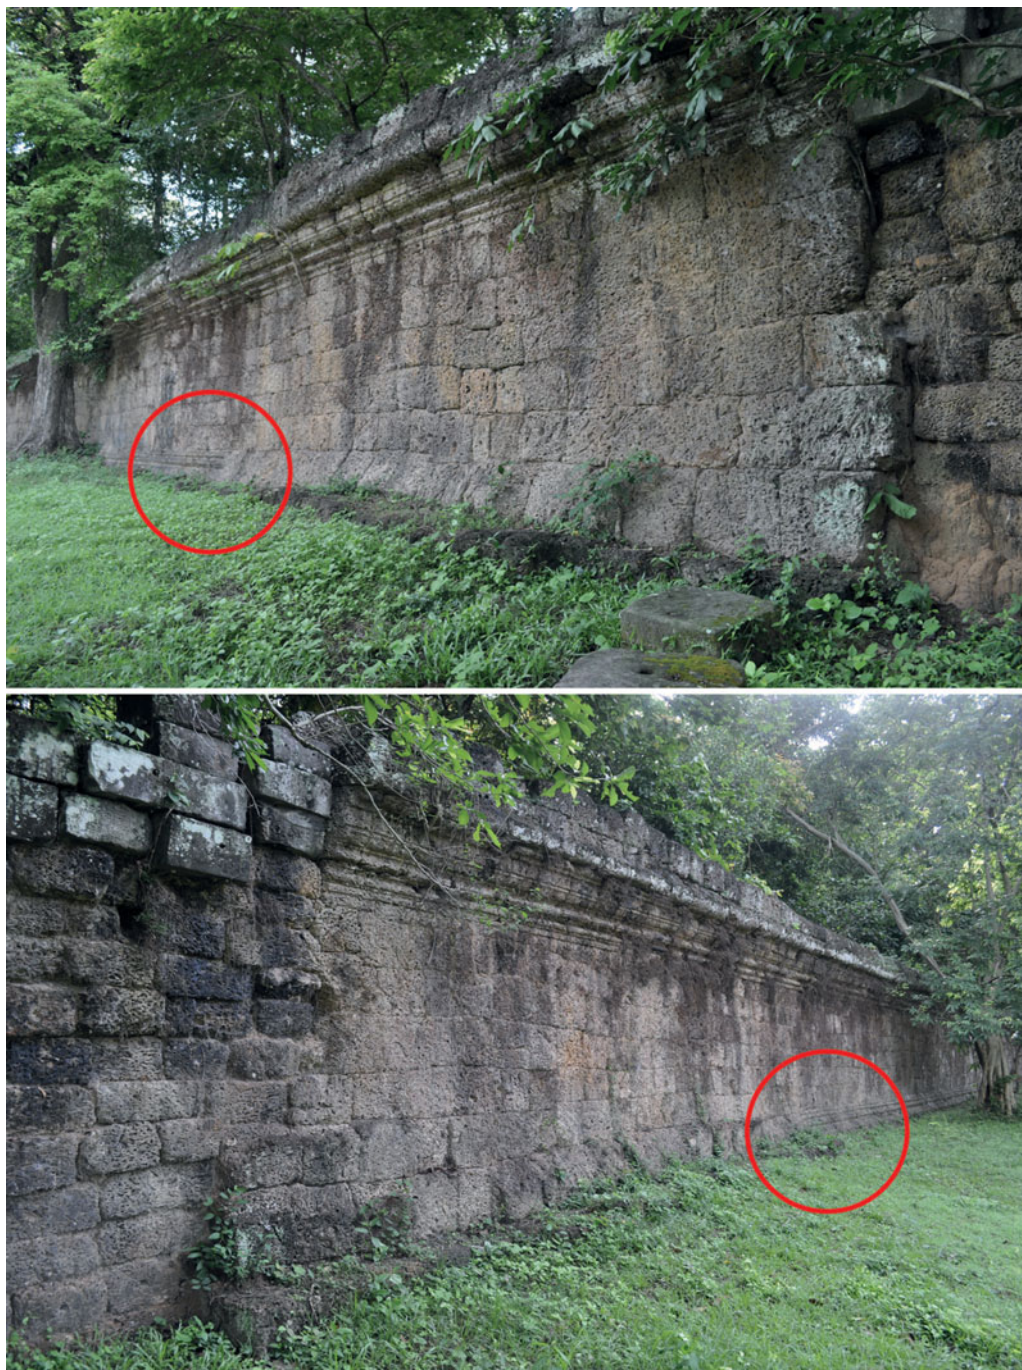
Figure 6. Gateway gap in the south wall, west side, facing west (top) and east (bottom); note the unfinished surfaces along the bottom edge of the wall adjacent to the gateway gap and the finer detailed blocks located farther away.

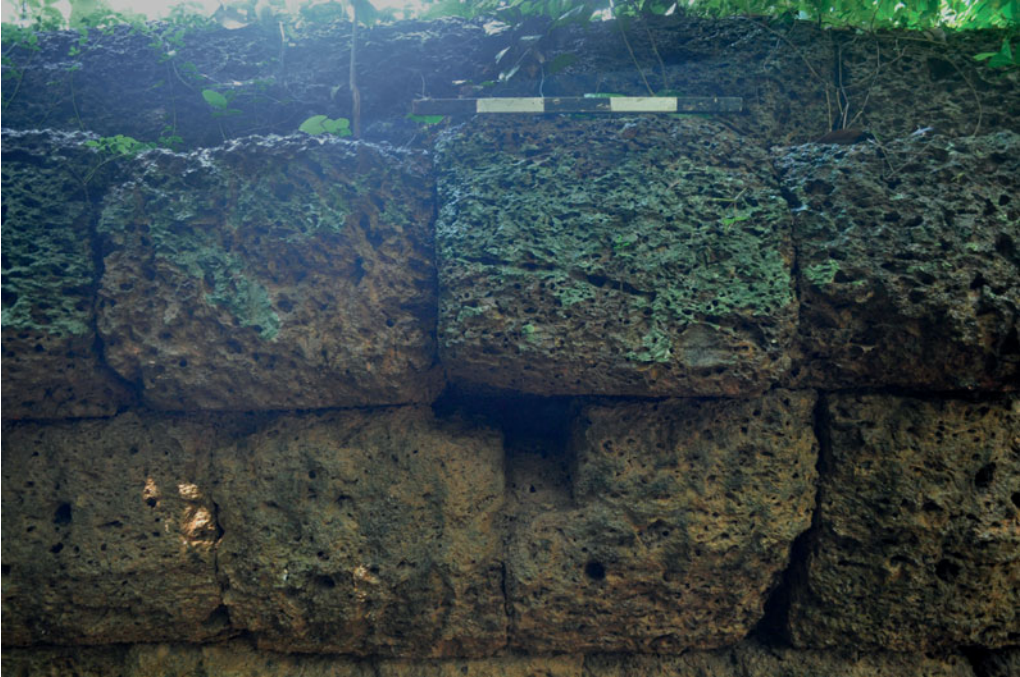
Figure 11. Irregular hole located to the upper left of a regular hole, forming an inverted L-shape.

There are two methods of establishing a relative chronology. The first is that regular and irregular holes in the inner face of the east wall are located at approximately the same height and the lines of irregular holes are often superimposed on the sets of regular holes, suggesting that the structures they supported could not have been coexistent. In several instances, however, the regular and irregular holes are conjoined to form an inverted L-shape (Figure 11). These coincident pairs demonstrate that the smaller irregular holes predate the regular ones, as the smaller cross section of the irregular beam would not fit securely if the larger hole were already there.
