The buried ‘towers’ of Angkor Wat

The impressive architecture of Angkor Wat conveys a sense of harmonious design, but recent survey using ground-penetrating radar (GPR), coupled with targeted excavation, reveals a more complex picture. Fragmentary traces of a quincunx of earlier towers have been detected, which were partially demolished when the outer enclosure and western gateway were completed. Are these the remains of a shrine used during the construction period? If so, they throw new light on associated ritual activity during the building of Angkor Wat.

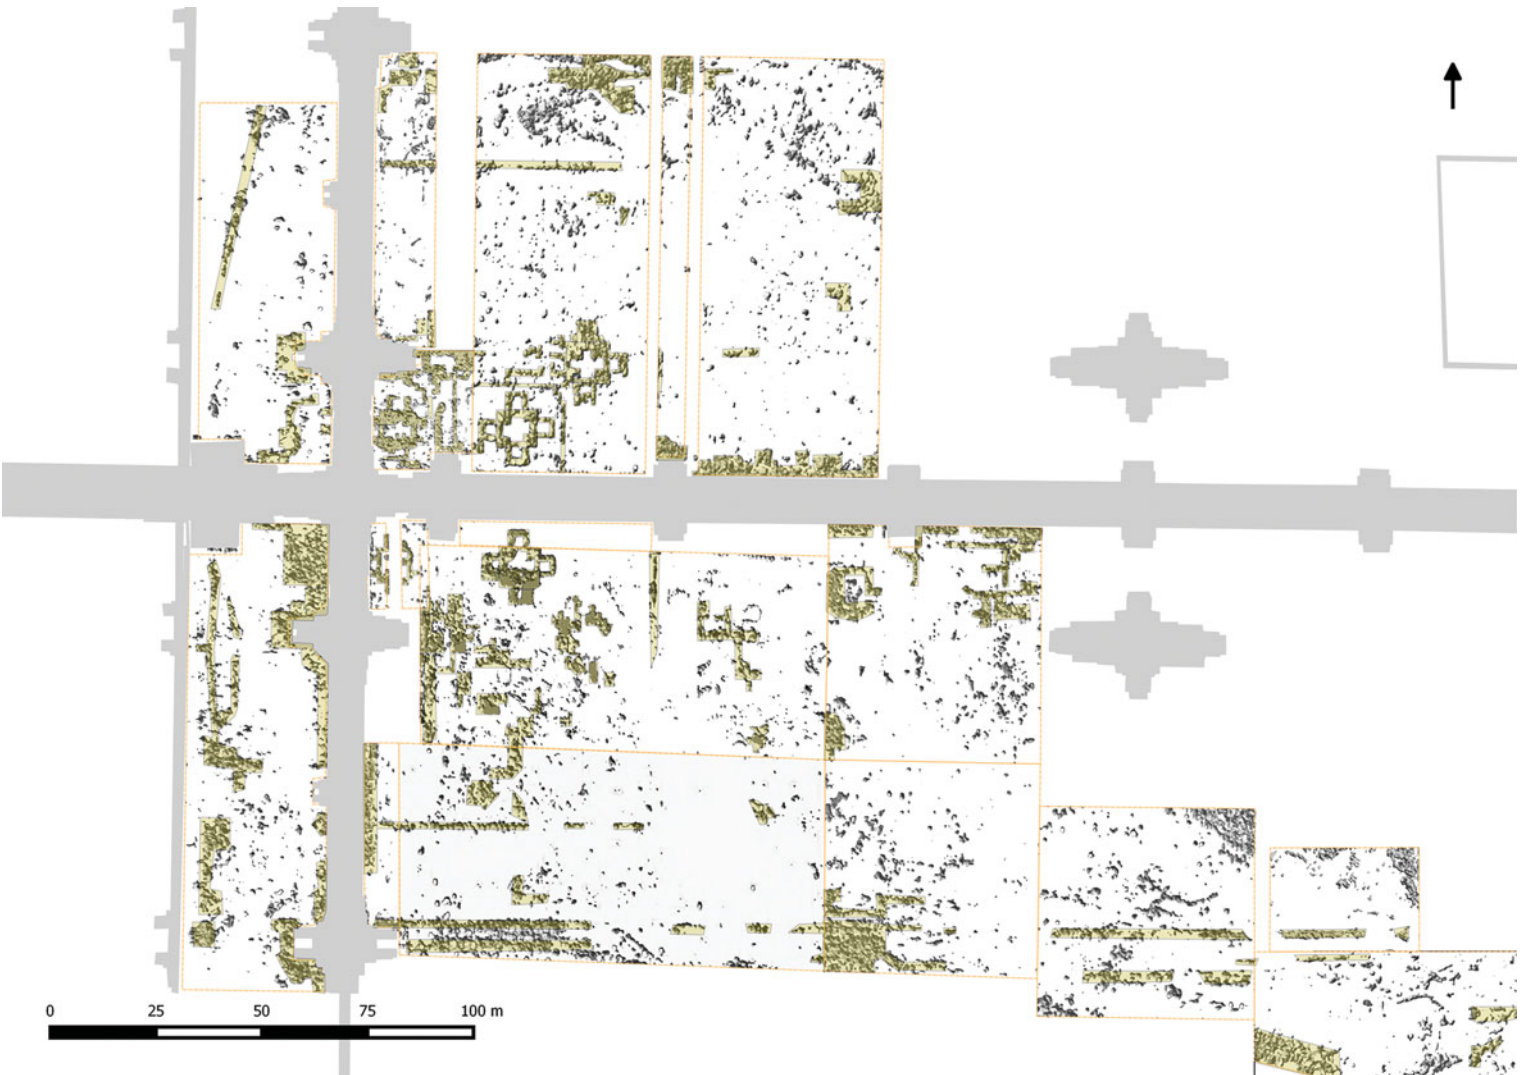
Figure 2. GPR survey results (iso-surface of major reflections) around the West Gopura, Angkor Wat.

Angkor Wat (Figure 1) is an icon of World Heritage and one of the world’s most intensively visited and studied monuments (Fletcher *et al.* 2015: 1390 & 1398). Yet in December 2009, a ground-penetrating radar (GPR) survey, extending over an area of 4.3ha (Sonnemann 2011: 141), which sought to investigate whether the fourth enclosure at the site was used for residential and administrative purposes (see Stark *et al.* 2015), detected a number of geometrically arranged cruciform features (Figures 2 & 3). Two of these, N1 and S1, are

A symmetrical linear feature about 1m wide (S6 and N6) exists south, east and north of the cruciform structures (Figures 2 & 3) and is perhaps part of a rectangular boundary around the set of structures. There is, however, no trace of an equivalent feature west of the outer wall of the fourth enclosure. A deeply buried linear north–south feature (Figure 6) was found in this area by the Italian-Cambodian team during 2001–2002. Photographs kindly provided by Valter Santoro indicate that this is a thick ridge of clay that may be of some significance.

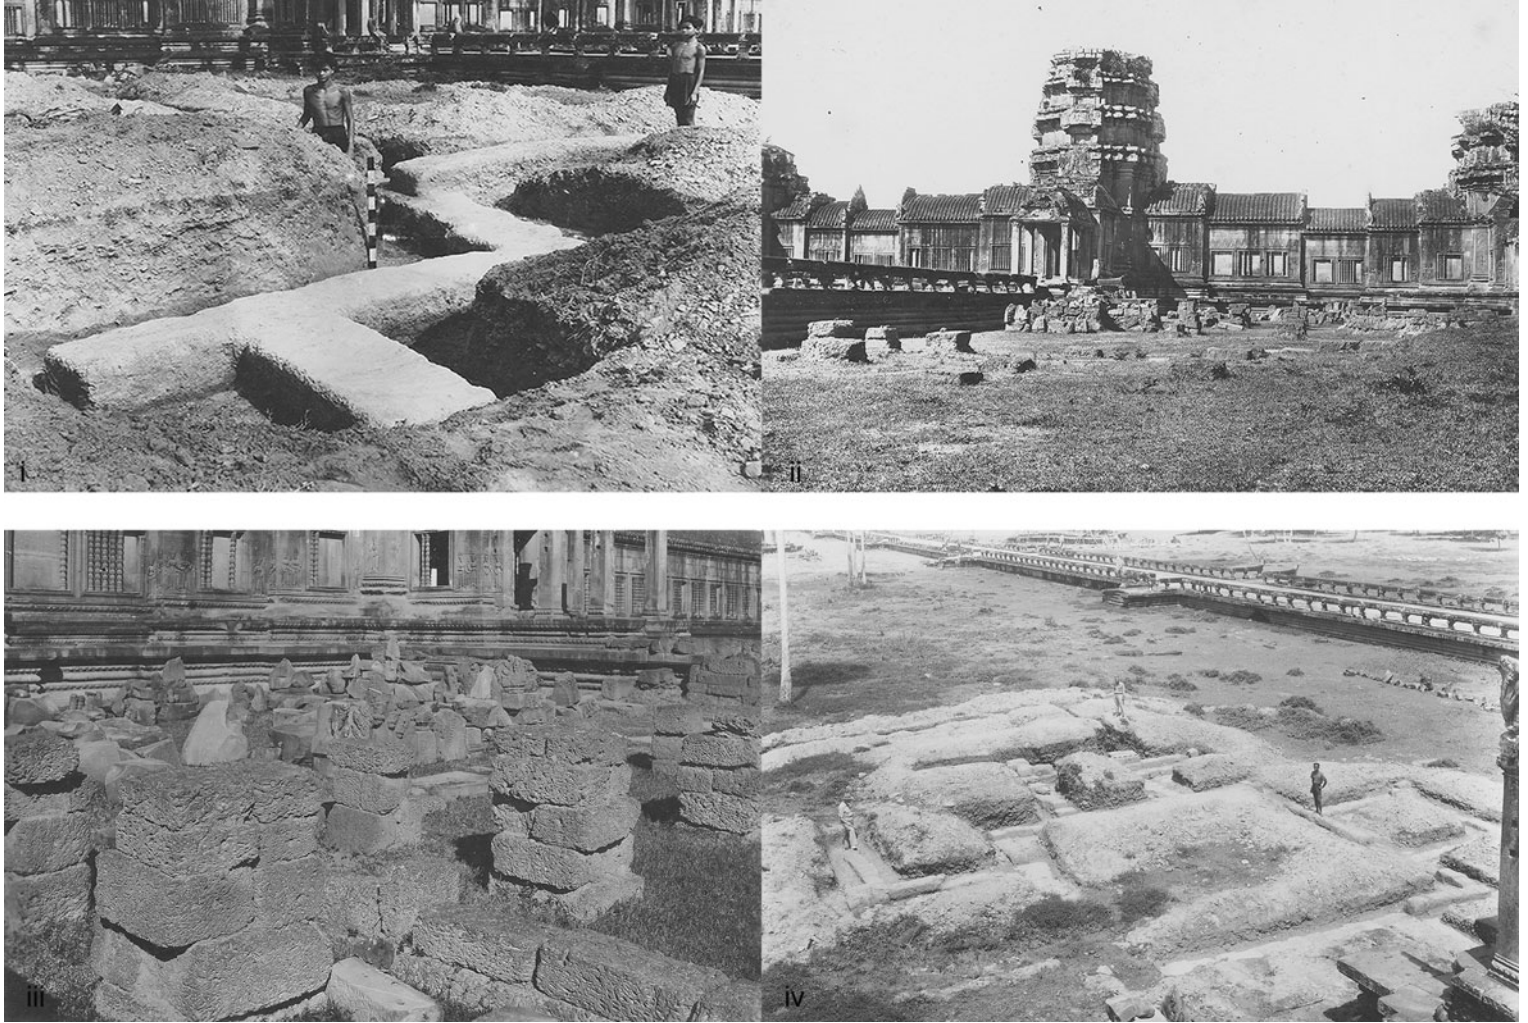
Figure 4. Historical l'École française d'Extrême-Orient (EFEO) photographs of excavations close to the eastern side of the West Gopura (4i—CAM05141, 4ii—CAM05393, 4iii—CAM05395, 4iv—CAM05581; images courtesy of EFEO)

slightly larger than the others and abut the outer porches of the West Gopura (a roofed gateway). Several other groups of features were also found both to the west and east of the entrance gate. Some of these features had been located in the early- to mid-twentieth century, when the Conservation d'Angkor carried out excavations along the causeway and in the vicinity of the West Gopura, exposing a succession of later constructions and parts of the masonry of some of the cruciform structures (Figures 4 & 5).

of the West Gopura, as they abut its north and south porches. They are aligned only with S2 and N2 on the east side of the West Gopura, and were also connected to the *perron* by the pillared galleries. The construction date of N1 and S1 cannot be, as yet, precisely resolved. They may have been built soon after the West Gopura porches were completed and may have also been associated with the laterite pillar galleries of a somewhat later addition (see Figures 4 & 5).

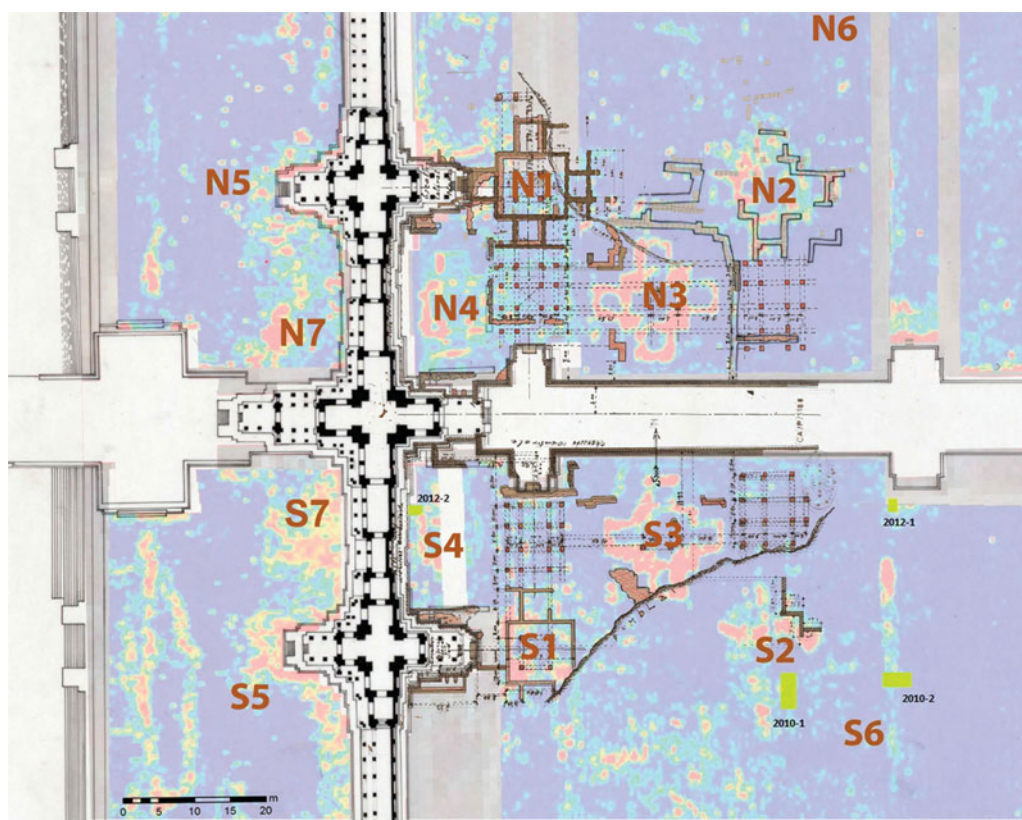
Figure 5. Features identified by EFEO in previous works (based on PLANSCA_0488, PLANSCA_1773, PLANSCA_1781, PLANSCA_1782, PLANSCA_1977a, PLANSCA_1977b and Nafilyan 1969: pl. 67).

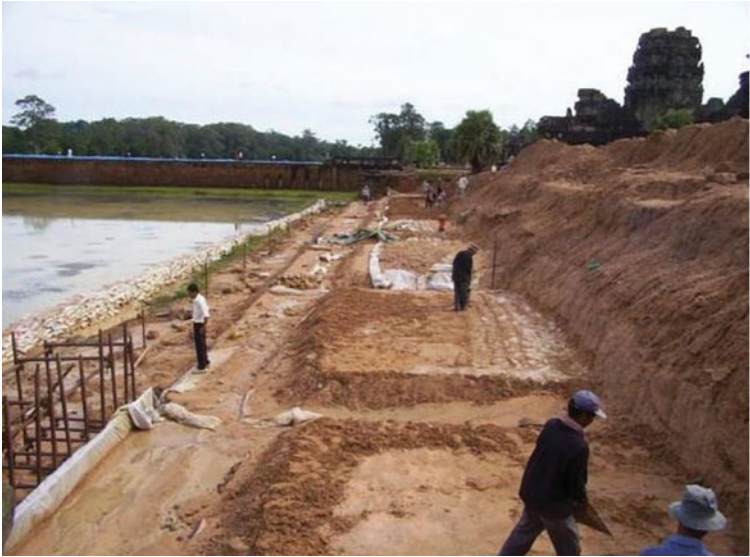
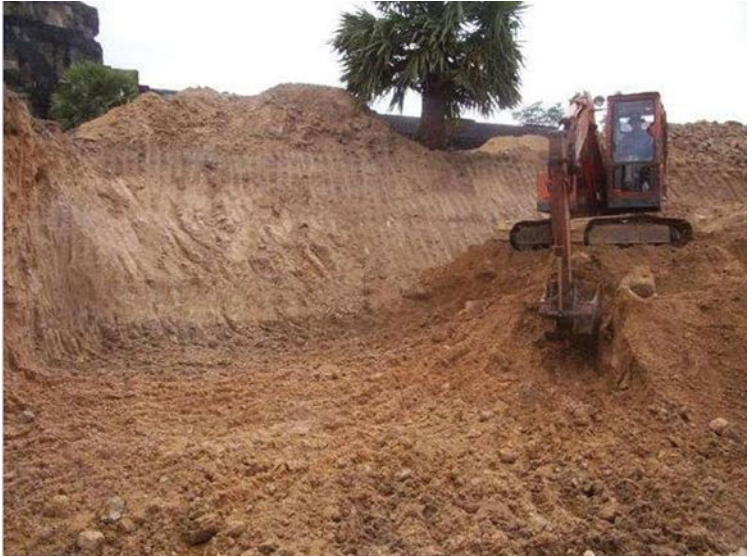
Figure 6. The moat repair in 2003/2004 displays the massive buried clay embankment (image courtesy of Valter Santoro 2005).

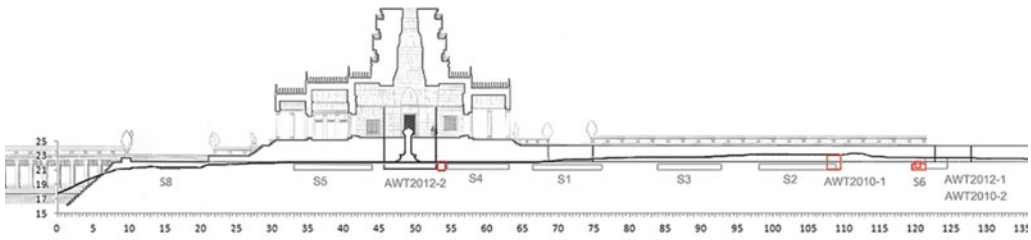
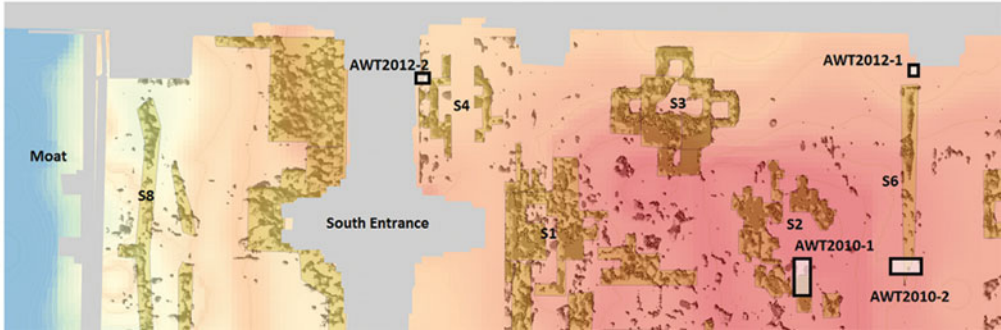
Figure 7. Excavation locations, horizontal and vertical location of trenches (temple elevation based on Nafilyan 1969).

Under specific agreements with the APSARA National Authority (Authority for the Protection and Management of Angkor and the region of Siem Reap), four test locations to the south of the central causeway were excavated by the Greater Angkor Project in order to obtain additional information on the form, stratigraphy and chronology of the various features (Figure 7). Two of these (trenches AWT2010-1 and 2) were laid out in June–July 2010 to investigate S2 and the boundary structure. These were excavated by Dougal O'Reilly, Chhay Rachna, Till Sonnemann, Suy Pov, Noel Tan

and Nick Gani. Then followed two small trenches in April 2012 (AWT2012-1 and 2), excavated by Chhay Rachna with Martin Polkinghorne, to assess the relationship of S4 to the West Gopura and the relationship between the boundary structure and the main causeway.

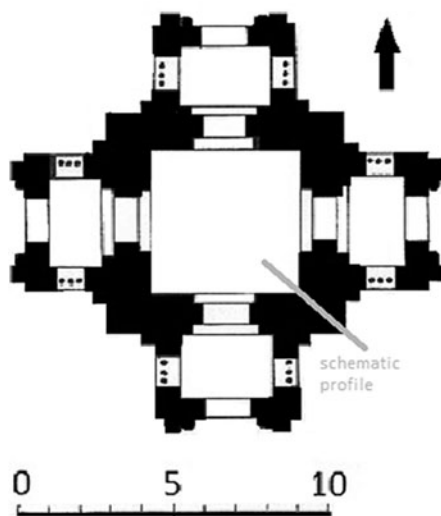
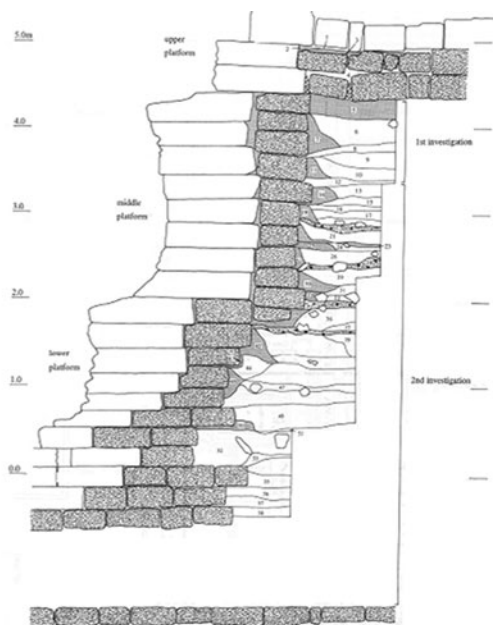
Schematic plan of a four porch shrine tower

Bayon - profile of layered sand foundation behind a masonry wall (courtesy JASA)

Figure 9. Plan of tower of an Angkorian shrine and section through wall of an Angkorian structure—one of the 'libraries' of the Bayon (image courtesy of JASA).

in the basal sand of the artificial platform on which the temple of Angkor Wat is built. Above this, the body of structure S2 displays alternating layers of sand and rock chips, held in place by laterite walls to form a raised platform—a typical feature of the foundations of substantial Angkorian buildings. The laterite walls are apparent in all the cruciform structures.

These structures resemble shrine towers in plan, with short porches facing in all four directions. These occur in other temples of the eleventh to twelfth centuries (Figure 9i). Boisselier identified this tower plan as a feature that appeared in Ta Keo in the late-tenth to early eleventh centuries (1966: 63). The same pattern of four short porches can be seen on all the corner towers of the main temple of Angkor Wat, even though two of the porches of each tower are embedded in galleries (Figure 10). An Angkorian shrine tower of the twelfth century was built with a sand core with a laterite casing (as seen in S2) but was usually also clad in sandstone as the decorative surface (Figure 9ii). No fragments from the demolition of sandstone masonry have, however, been found either in the excavation of the cruciform structures or scattered around the area. The rock-chip debris is from the initial chiselling down of newly emplaced blocks on other buildings during construction. It is not debris from demolition. The absence of any broken, finished sandstone blocks might mean comprehensive demolition and reuse (there are major constructions close by to which the blocks could be relocated), or it may indicate that the structures were never completed with a sandstone facing. This is at odds with the long-term effect of the cruciform structures on

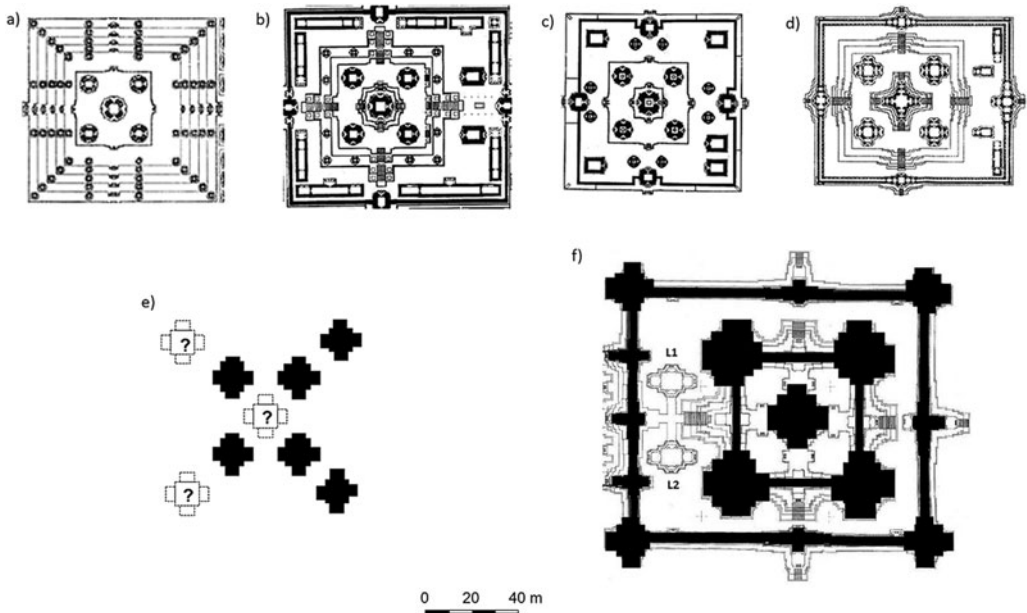
Figure 10. Comparison of cruciform structures of Angkor: a) Phnom Bakheng, early tenth century; b) pre-Rup, mid-tenth century; c) east Mebon, mid-tenth century; d) Takeo, late-tenth to early eleventh centuries; e) cruciform tower bases at G4W—schematic; f) Angkor Wat (source: a–d: Glaize 1944; f: Pottier 1993: pl. 40).

towers of the second enclosure. The *quincunx* configuration is known from the ninth century at Phnom Bakheng (AD 889–923) (Figure 10) and in other Angkorian temples (Boisselier 1966: 53), both on pyramids, as at the east Mebon (Stern 1933), built between AD 944 and 968 and on low platforms at Pre Chema Sram. The latter arrangement is rare. None of the buried 'towers' was raised on a high platform, so this configuration, as used in the western *quincunx*, was rather unusual. Whether this ensemble was a shrine used while the main temple was being built is an intriguing and, as yet, unassessable proposition.

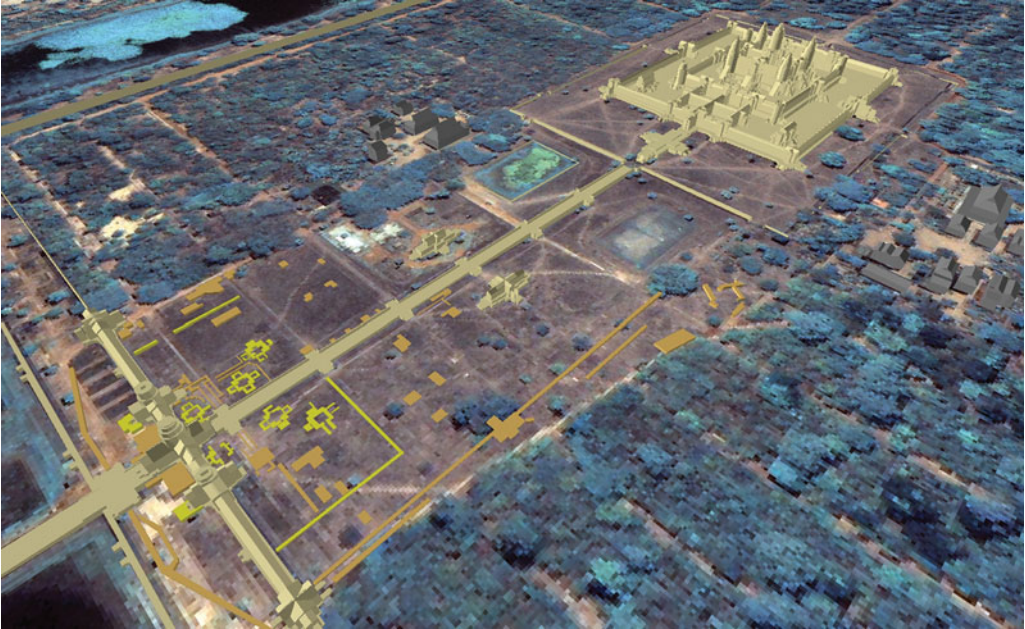
Figure 11. Overview of Angkor Wat showing relationship between the buried 'towers' and the position of the main Angkor Wat temple (by Sonnemann and image base courtesy of ETH Zurich).
