LATE CLASSIC MAYA DRAINAGE AND FLOOD CONTROL AT COPAN, HONDURAS

Karla L. Davis-Salazar

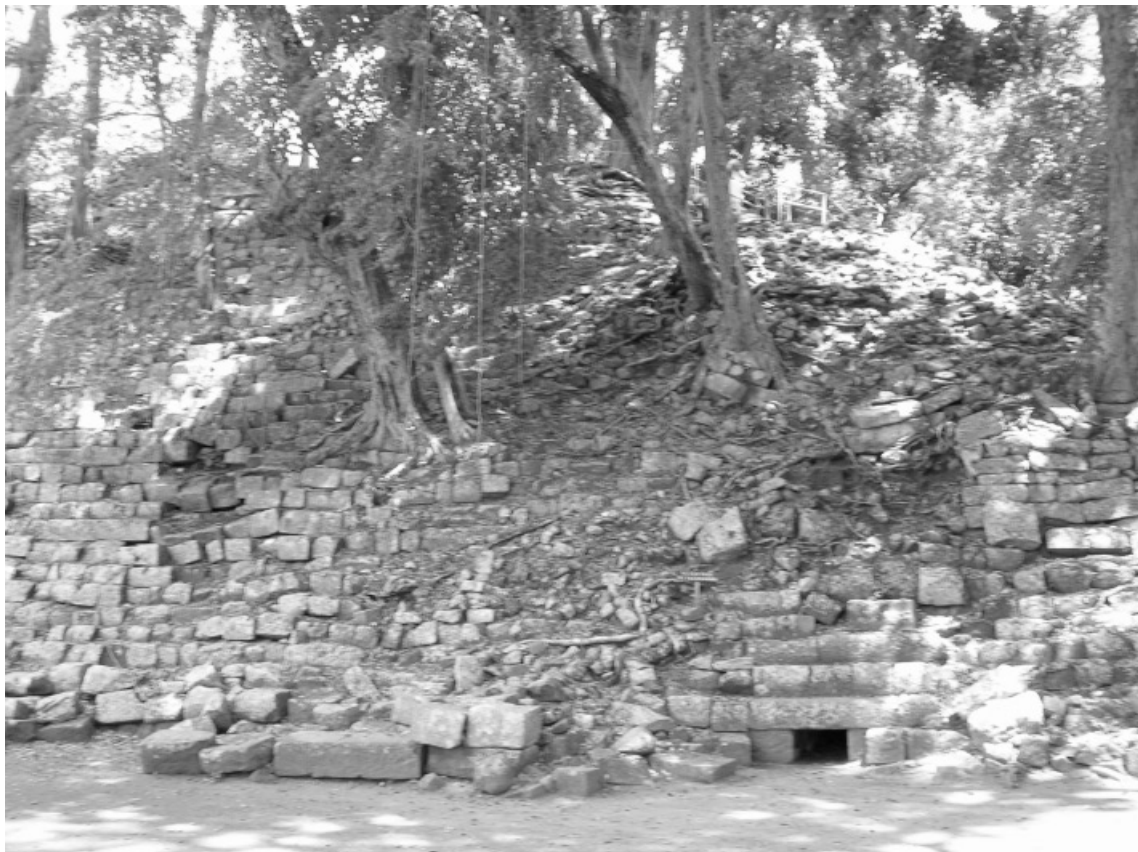
Figure 3. Inlet of the Structure 10L-11 substructure conduit (bottom right corner).

Substructure conduits are stone-lined features that drained semi-enclosed courtyard areas by flushing water through pyramidal bases and out the back side of structures. Two extant examples, the Structure 10L-11 drain and the East Court drain, remain in use today. The Structure 10L-11 drain is a large conduit that passes through the northwestern corner of the pyramidal base of the structure (Figures 2–3). This drain continues to empty the entire Great Plaza and Plaza of the Hieroglyphic Stairway today, as it did more than 1,000 years ago. The conduit is constructed of dressed blocks of volcanic tuff characteristic of the civic-ceremonial architecture of the Acropolis and would have been planned with the final phase construction of Structure 10L-11. Its aperture measures .64 m wide by .5 m high. Its estimated length beneath the pyramid is 40 m, and it continues for at least another 15 m southwest after exiting the structure. Nine meters after exiting the substructure, the construction material changes to small, cut blocks of volcanic tuff, which may or may not be contemporary in origin. Today, discharge from the conduit heads off in a southwesterly direction into the urban ward of El Bosque.

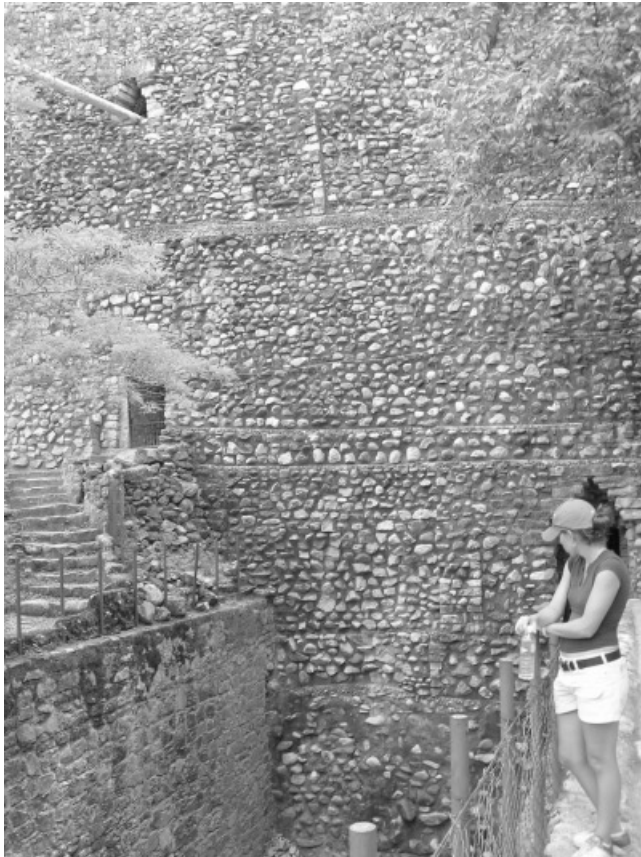
Figure 4. Outlet of the East Court substructure conduit (upper left corner) as exposed in the archaeological cut of the Acropolis (note protruding PVC pipe used to drain the East Court today).

Another large substructure conduit, running under the now destroyed Structure 10L-20, drains the East Court (Figures 2, 4). It exits east off the sheer vertical face of the archaeological cut of the Acropolis, thus earning its nickname “La Ventana” (The Window). Undoubtedly, water running through this conduit and others for more than 1,000 years contributed to the substantial erosion and partial destruction of the east side of the Acropolis and may have even altered the course of the Copan River (Fash 2005:137). The drain opening measures .8 m wide at the base and 1 m high. Although constructed of dressed blocks of volcanic tuff, this drain differs significantly from the Structure 10L-11 drain in that the roof of the East Court drain is vaulted with four courses of dressed stone, suggesting the need for more structural integrity or a desire for a more aesthetically pleasing appearance.

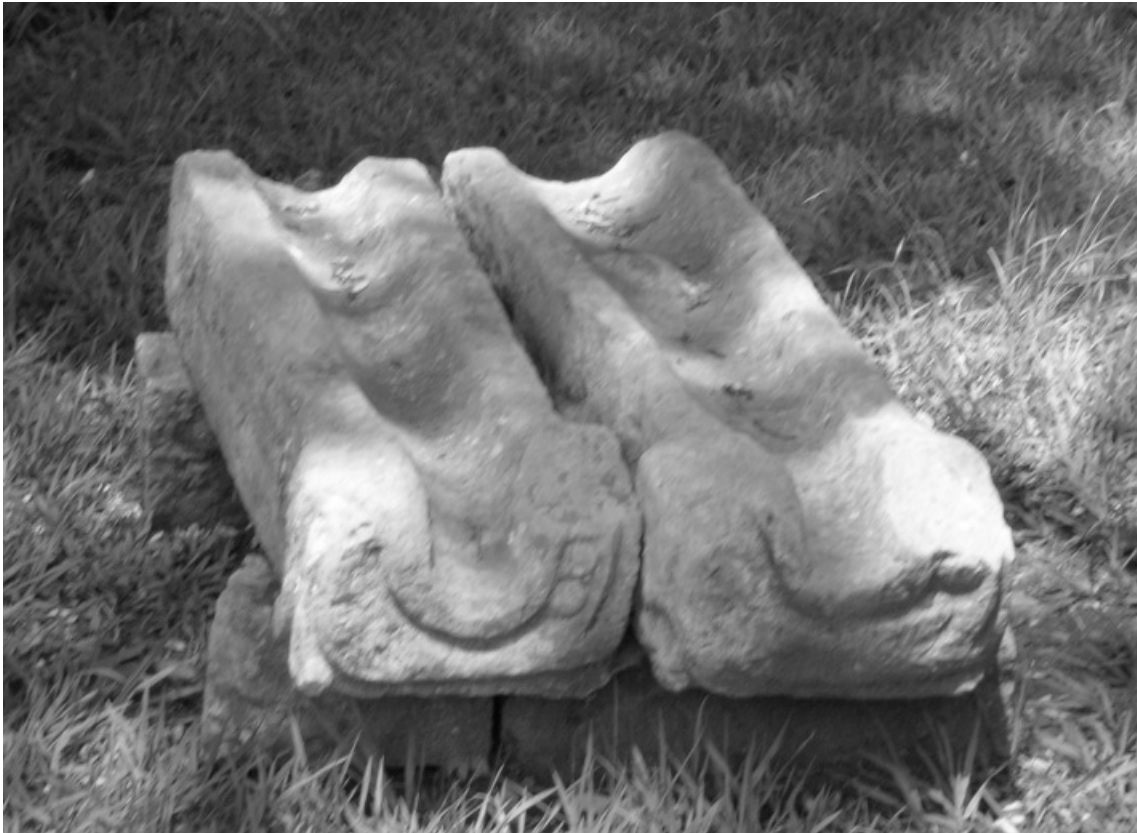
Figure 6. Roof drains found in the Principal Group.

Roof drains are long (.5 m–2 m), sculpted, U-shaped, stone features tenoned off the vertical face of masonry superstructures (Figure 6). These features were designed specifically to manage runoff from the roofs of individual buildings. The channels of roof drains at Copan range from approximately .4 m to .9 m deep and .7 m to 1.1 m wide. One advantage to roof drains was that they directed water away from building walls and thus protected stucco plastering and/or sculpture adorning exteriors. The use of roof drains in elite and civic-ceremonial architecture was ubiquitous, as they have been found all over the site.

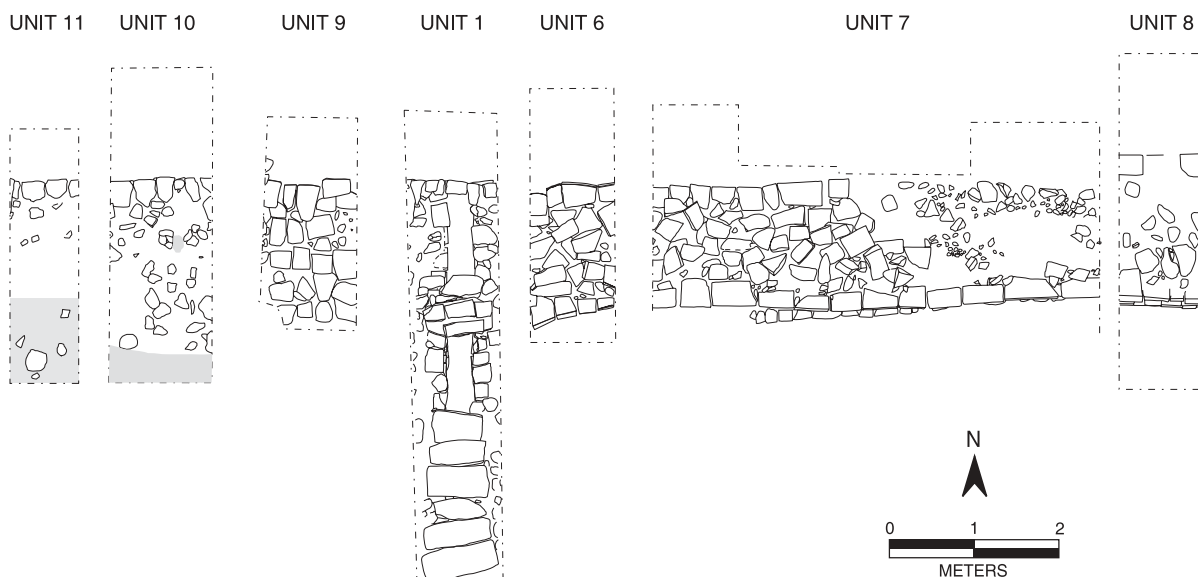
Figure 9. Plan view of the parapet of the early west causeway in El Bosque.

Excavation of the conduit revealed an earlier construction phase of the west causeway, which also dated to the Late Classic (Coner-phase) period based on ceramics found in the construction fill. The earlier west causeway consisted of a white stucco pavement bordered on the north side by a masonry parapet. The causeway, excluding parapet, measured approximately 9.3 m wide. The parapet, constructed of cut stone, measured an average of 1.6 m wide and minimally .85 m high (Figure 9). Near the Great Plaza, the causeway was constructed by laying gravel ballast on the ground surface and then plastering over it with stucco. As one moves west, however, the natural ground surface decreases in elevation due to natural drainage patterns. To maintain a level surface and raise the walkway above potential flood areas, the causeway was built up with fill and retained, at least on the north side, by a masonry wall. This is evident in the increasing height and number of courses of the north masonry wall of the causeway as one moves from east to west. Along the 70 m stretch of the north facade that was excavated, the height of the causeway foundation increased from ground level in the easternmost test pit to .85 m (5 courses) in the westernmost. The total height of the north side

of the causeway, including parapet, was minimally 1.7 m in some sections. Thus, the masonry wall created by the causeway foundation and parapet would have been effective at retaining and diverting the southerly flow of stream discharge and rainfall runoff. Certainly, the parapet would have prevented water from washing onto the causeway near the Great Plaza where the causeway pavement was laid at ground level. The north masonry facade of the causeway, capped by a parapet, was significantly more formal than the southern edge of the causeway, where the ballast feathered out.
