Biofilm formation on bone-anchored hearing aids

P MONKSFIELD¹, I L C CHAPPLE², J B MATTHEWS², M M GRANT², O ADDISON³,
A P REID¹, D W PROOPS¹, R L SAMMONS³

Objective: To investigate microbiological biofilm contamination of retrieved bone-anchored hearing aids.

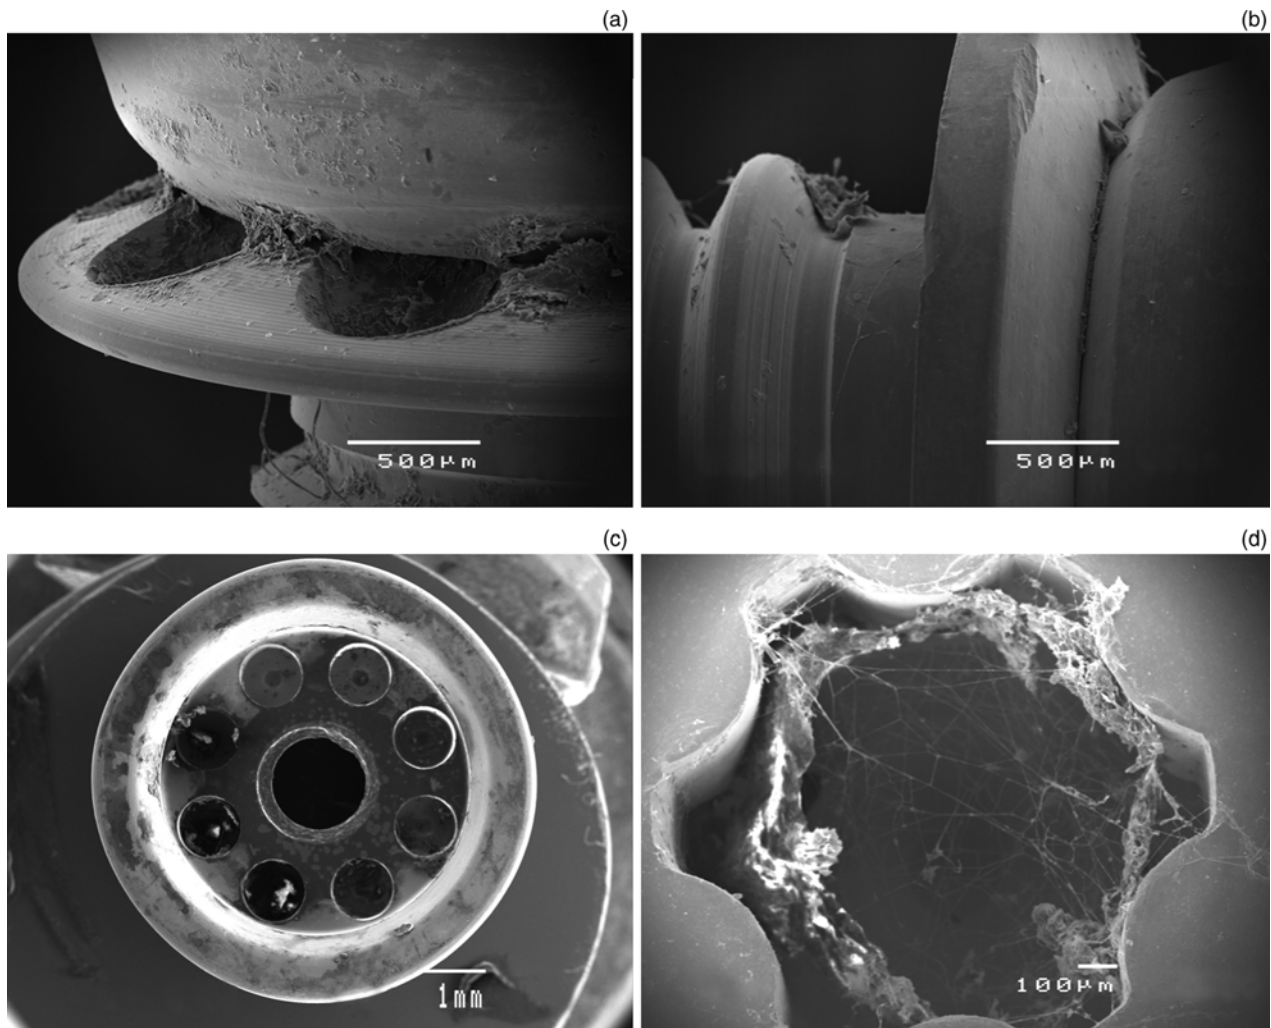
FIG. 1

Scanning electron microscopy revealed debris and signs of cellular and bacterial colonisation on the titanium fixture screws and abutments of all nine implants examined (Figure 1). Debris appeared as a thick encrustation between the threads of the fixture and on the external parts of the abutment and the internal screw tightening notch. It was unsurprising to find such material on the fixtures, as they had been in contact with human tissue.

Representative scanning electron micrographs of bone-anchored hearing aid implants and components. (a) Junction between the bone-anchoring fixture and the abutment, showing dried biofilm on the fixture flange (in the circular depressions in this design) and at the junction with the abutment. (b) Another implant design with a solid flange, shown lying on its side, demonstrating deposited material at the junction with the abutment and attached to the screw threads of the fixture. (c) The top of an abutment, showing deposited material around the rim; the central hole gives access to the internal screw head connecting the abutment to the fixture. (d) The top of an internal screw, showing biofilm in the screw driver engagement notch.

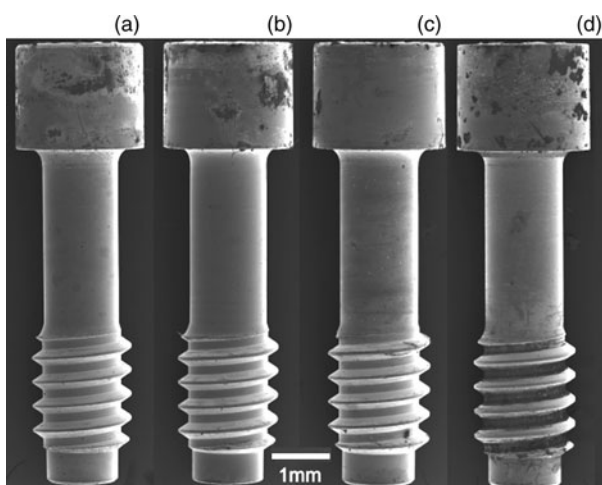
FIG. 2

However, unexpectedly, contamination was also observed on six of the internal screws from these nine implants. Ten additional, used screws were then examined to investigate this further. Scanning electron micrographs for four of the retrieved screws are shown in Figure 2. All sixteen screws examined showed contamination of the screw head. This was expected, since the screw head is exposed to the external environment and the top tightening notch of the screw head may be contaminated, as seen in Figure 1(d). However, eight screws showed evidence of biofilm extending down the shaft and into the space between the screw threads, where it was several micrometres thick (see Figure 2d).

Representative scanning electron micrographs of four internal screws, showing contamination of all screw heads and extensive biofilm formation on the shaft and between the screw threads (d).

The current study aimed to investigate evidence of biofilm formation on retrieved BAHAs, focussing especially on the internal connecting screws. We found contamination on the heads of all 16 screws examined; furthermore, eight screws showed evidence of thick biofilm formation on the shaft and between the screw threads. In at least one case, the biofilm appeared also to exist in the space between the abutment and the fixture, where it could potentially shed micro-organisms into the surrounding tissue. In the one case in which individual bacteria could be clearly distinguished, the biofilm consisted of a mixed population of bacterial types. The suggestion that viable bacteria may colonise the BAHA internal screw was supported by culture of staphylococcus from the internal screw of a BAHA unit that had been placed for only 15 days but had failed to osseointegrate (and was then removed and disassembled under aseptic conditions). Scanning electron micrographs of the contaminated screw revealed other bacteria which may have coexisted with the staphylococcus, and which were presumably not detected by culturing because of specific growth requirements (as is the case with many anaerobic species). (In future studies, the use of molecular methods would facilitate the identification of such uncultivable bacteria.)

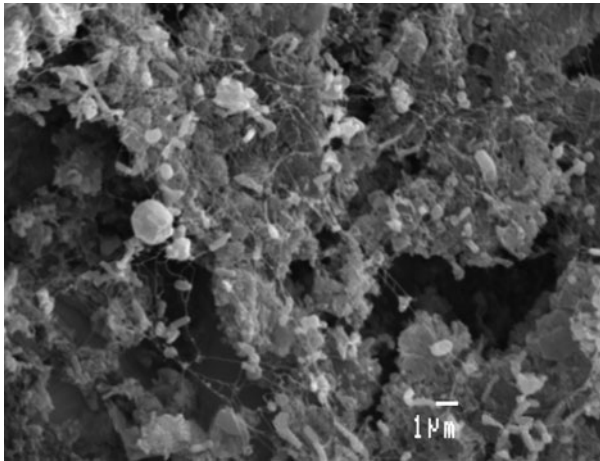
FIG. 3

In most cases, because the samples had been simply allowed to dry and placed in saline or formalin, rather than being prepared for scanning electron microscopy using appropriate fixatives and dehydration, individual bacteria could not be distinguished clearly. However, in some cases (e.g. the sample shown in Figure 2d) the bacterial morphology was sufficiently well preserved to distinguish between cocci and rods; Figure 3 shows a mixed population of both morphological types.

Higher magnification scanning electron micrograph of the biofilm on the threads of the screw depicted in Figure 2(d), showing a thick encrustation with a mixed bacterial population of rods and cocci of various sizes. (Bar = 1 μm)

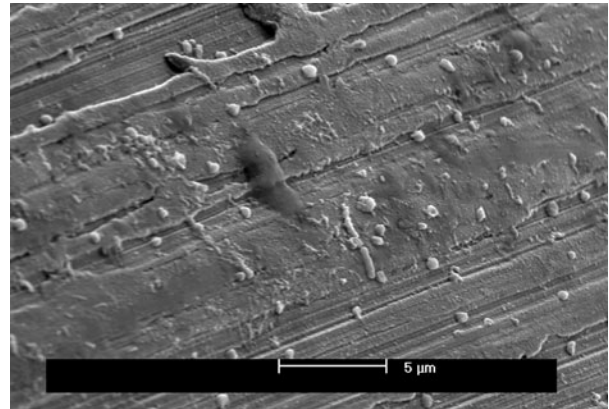
FIG. 5

To determine whether viable organisms could be cultured from a failed BAHA, a freshly retrieved fixture that had failed to osseointegrate after 15 days was transported to the laboratory in a sterile container. The fixture was immediately placed in sterile saline to preserve biofilm structure and microbial viability. It was then disassembled under aseptic conditions, and the internal screw incubated anaerobically in liquid broth culture. After 24 hours, this yielded a culture of micro-organisms which, when subcultured on blood agar, grew in both aerobic and anaerobic conditions. The colonies were homogeneous, small and white, and consisted of Gram-positive cocci. They were identified as staphylococci by a positive catalase test, but the species was not determined. Subsequent scanning electron microscopy of the cultured screw revealed clusters of cocci, as expected, but occasional bacilli were also seen, and some areas of the screw were covered in a biofilm-like matrix (Figure 5).

Field emission gun environmental scanning electron micrograph of biofilm on a retrieved bone-anchored hearing aid screw, following microbial culture. Cocci and rod-shaped organisms can be seen, in addition to amorphous deposited material. (Bar = 5 μm)

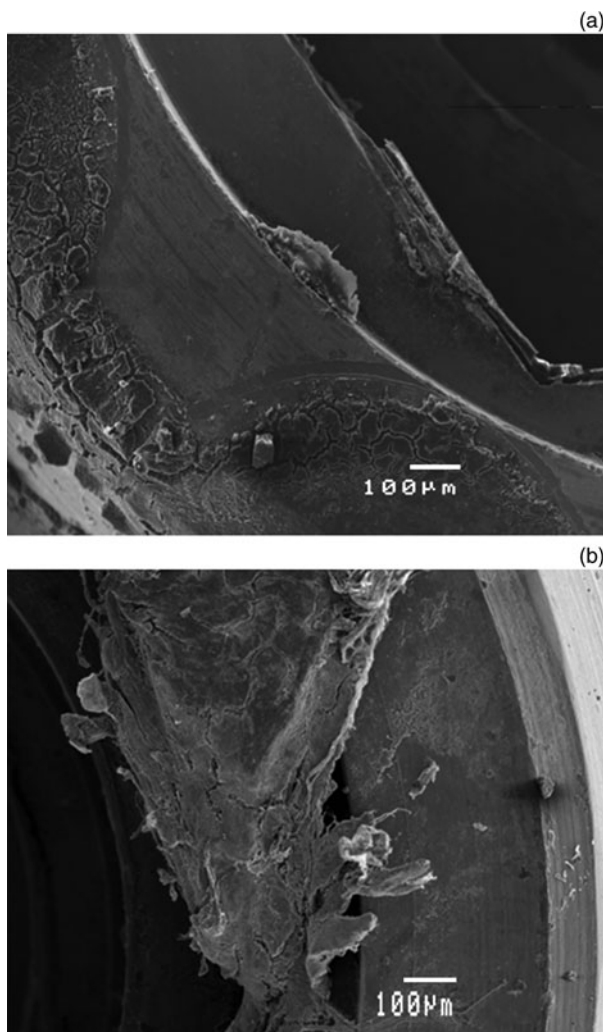
FIG. 4

As all 16 internal screw heads examined showed evidence of contamination, it is reasonable to contend that this is the most likely portal of entry for fluid and micro-organisms. To investigate whether bacteria could also gain entry or exit between the abutment and the fixture, we examined six ‘upturned’ abutments for any evidence of biofilm between the abutment and the fixture. In most cases, we found deposited material only on the rim of the abutment (where it would have been exposed to minimal contamination by fluid from the surrounding tissues), although the encrustation was quite heavy (Figure 4a). The abutment from which we obtained the heavily contaminated screw shown in Figure 2(d) showed biofilm extending into the screw hole, suggesting that this could indeed be a portal of entry or exit for micro-organisms, connecting the spaces around the internal screw threads to the surrounding tissues (Figure 4b).

Representative scanning electron micrographs of 'upturned' abutments after disassembly, showing the surface that was in contact with the fixture. Biofilm can be seen in both micrographs: in (a) it is mostly confined to the outer rim, while in (b) (the connecting abutment of the screw shown in Figure 2d) the material is much thicker and occupies the area within the rim.

Penetration of micro-organisms into the spaces surrounding the internal screw thread is most likely to occur after implant placement, with the most likely portal of entry being the head of the screw, since this is exposed to the external environment and tissue exudate may collect around it. Scanning electron micrographs revealed contamination of the screw access hole of several abutments, as well as all the screw heads. Moreover, a new BAHA screw examined by scanning electron microscopy revealed no evidence of bacterial presence (Figure 6). However, whilst less likely, micro-organisms could possibly also gain entry between the abutment and the bone-anchoring fixture itself, at their point of apposition.

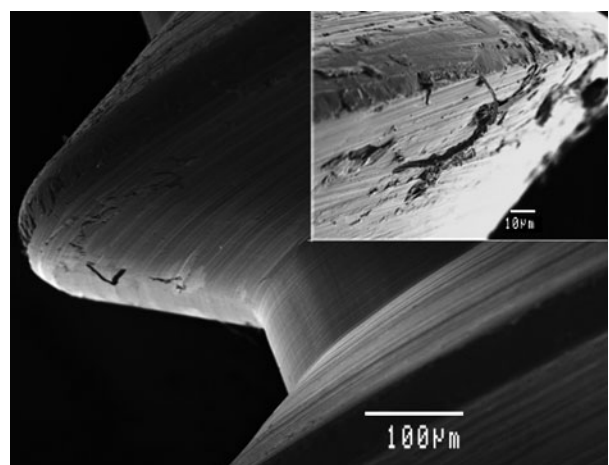
FIG. 6

We also undertook scanning electron microscopy of a new, sterile fixture. This confirmed the absence of any biofilm-like debris on any part of the fixture or abutment, including the internal screw, as expected. However, the surface showed machining marks, and there was obvious metal machining swarf on the threads of the internal screw (Figure 6).

Scanning electron micrograph of a new, unused bone-anchored hearing aid internal screw, showing machining marks, scratches and debris on the surface (bar = 100 μm). Insert shows a higher magnification view of the debris (bar = 10 μm).

Scanning electron microscopy of the unused fixture screw revealed that the surfaces of the threads were pitted, with machining debris attached to several threads. In some cases, this machining debris was several micrometres in width or length, and could be sufficient to impede thread engagement and therefore create space in which fluid could accumulate and any bacteria gaining entry could grow. It is likely that the machining debris was present before the screw was placed in the abutment; however, damage could occur during deployment, since gold is a relatively soft metal and easily deformed. Indeed, gold is selected for internal screws precisely because it can be deformed when screwed into the fixture, forming a tight seal. Titanium screws were previously used for this purpose, but they proved to be too hard and were discontinued because of failures due to loosening.
