The formation of a hydrotalcite coating on the aluminium alloy 6060 using a spray system

ABSTRACT: Coatings with the composition of Li-Al-NO₃ hydrotalcite were formed on the Al alloy 6060 using a spray system. The coatings consist of crystals with a typical hydrotalcite structure. Dense, uniform and blade-like flakes cover completely the surface of the Al substrate. The coatings display a multi-layer structure with average thickness of ~1000 nm. The hydrotalcite-coated samples performed better than those without coatings in salt-spray and filiform-corrosion tests, and further treatment involving sealing with a Mg acetate solution and dipping in a H₂O₂ + Ce-based solution improved the corrosion resistance ability.

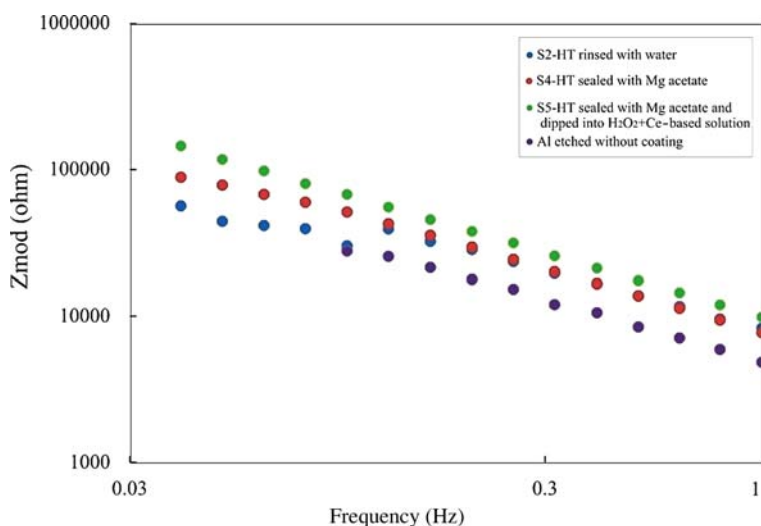
Data for electrochemical-impedance measurements on coatings with different treatments are shown in Bode plots in Fig. 5. The <1 Hz frequency is relevant to the corrosion reaction, and large impedance values correspond with the high corrosion resistance of the coatings (Mansfeld & Kendig, 1988). The

FIG 5. Bode impedance plots for the Al alloy 6060 with hydrotalcite coating.

Micro-cracks favor the decomposition of coatings by increasing the number of defect spots. These defects can result from mechanical damage, edge alignment or disturbance of the coating. During the filiform-corrosion test, the main culprits were chlorides together with moisture and oxygen which promote the migration of a local anode through the defects at the interface of the coating and the Al alloy, and the corrosion signature is shown as ‘fibril development’. During the sealing process, the number of cracks on the hydrotalcite film can be reduced significantly by precipitating new crystals on the Al substrate through the channels provided by the cracks, and therefore a relatively uniform film was developed. In the experiments described, the Al alloy with hydrotalcite film was exposed to a later treatment bath with magnesium acetate (Mg(C₂H₃O₂)₂). The Mg²⁺, OH⁻ and CO₃²⁻ released from the dissolution of magnesium acetate in the later treatment solution may replace the Li⁺ and NO₃⁻ in Li-Al hydrotalcite to form new crystal phases which include Mg(OH)₂ ± Mg-Al-CO₃ hydrotalcite, and therefore sealing the cracks and providing a better corrosion-resistance performance of the film (Fig. 5).

Compared to the hydrotalcite coating sealed with Mg acetate, further dipping of the coated alloy in H₂O₂ + Ce(III)-based solution can lead to the deposition of Ce hydroxide/oxide layers, and consequently improve the corrosion-resistance ability (Figs 5, 6).
