An Outbreak of Legionnaires Disease Associated with a Decorative Water Wall Fountain in a Hospital

DESIGN AND SETTING. Epidemiologic investigation of an acute outbreak of hospital-associated Legionnaires disease among outpatients and visitors to a Wisconsin hospital.

Infect Control Hosp Epidemiol 2012;33(2):185-191

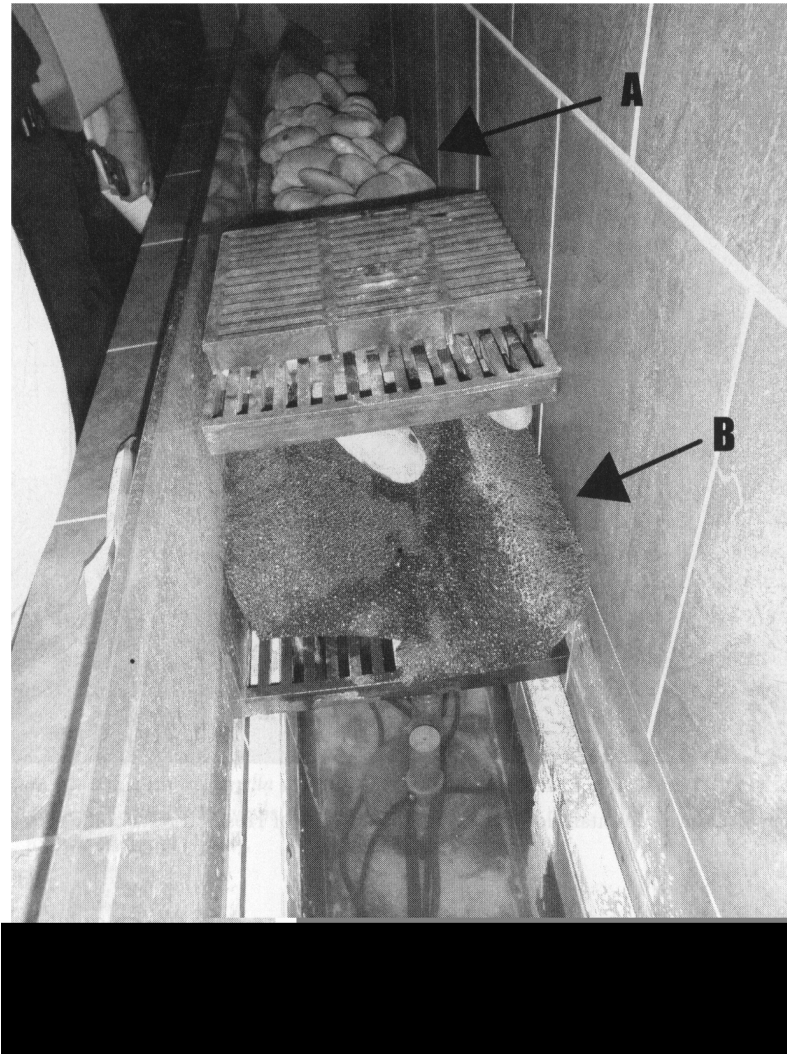
FIGURE 2. Internal view of the water wall-type fountain, showing a bed of decorative rocks that rested on a spongelike foam material. Arrow A points to the decorative rocks in the fountain, and arrow B points to the location of the foam material that was placed in the fountain to prevent splashing. A color version of this figure is available in the online edition.

The water wall-type decorative fountain was installed in 2008 on one side of a central corridor in the main Hospital A lobby (Figure 1). All visitors using the hospital main entrance passed by the fountain on their way to the information/registration desk. Fountain water flowed down a tiled wall approximately 8 ft wide and 5 ft high and then through a bed of decorative rocks that rested on a spongelike foam material (Figure 2). A glass shield extended from the trough approximately 6 in above the rocks to reduce splashing into the corridor. The water collected in a trough at the bottom of the fountain, beneath the rocks and foam, and an electric pump recirculated the water to the top of the water wall. Low-voltage floodlights were located on the ceiling above the fountain and in the water trough. The fountain was in use daily between 6:00 AM and 9:00 PM and was turned off at night. An electric fireplace was located on the opposite side of the same wall that housed the fountain and was used intermittently during the same hours as the fountain.

The fountain was equipped with an ionization-based disinfection system (Model 1100 Automatic Purification System, Carefree Clearwater). Weekly maintenance by hospital staff included testing fountain water for free chlorine, total alkalinity, and cyanuric acid using the Hth pool kit (test strips); testing for total dissolved solids (conductivity test); and adding 1 half-gallon of hydrogen peroxide and 1 oz of biocide to the water. Monthly maintenance included shutting down the water wall and removing the rocks, foam, metal grates,

and white drain pipe. The walls, trough, sump, and pump were cleaned with CLR cleaner and rinsed with tap water. A wet-dry vacuum was used to remove water that remained in the bottom of the sump. The rocks and foam were rinsed with tap water and placed back in the fountain. Facility staff followed manufacturer maintenance recommendations for the pump.

This investigation detected 8 laboratory-confirmed cases of Legionnaires disease diagnosed during a 4-week period among persons whose only common exposure during the 10 days prior to illness onset was a visit to Hospital A. None of the 8 persons had been inpatients at the time of their exposure. Environmental testing detected Lp1 in samples collected from a water wall-type decorative fountain located in the Hospital A main lobby. Lp1 were present in high concentrations in 4 samples of a foam material used to support

a bed of decorative rocks above the fountain trough and at lower concentrations in a water sample and swab specimen collected from the fountain filter housing and a water sample collected from the fountain trough. These 7 isolates had indistinguishable PFGE patterns. The only other sample positive for Lp1 had an isolate with a different PFGE pattern.

sociated with decorative fountains in healthcare settings and the efficacy of disinfection/maintenance procedures to reduce such risks. Accordingly, WDPH staff developed interim guidelines advising healthcare facilities with similar wall-type water fountains or any other decorative fountains to establish strict maintenance procedures and conduct periodic bacteriologic monitoring to assess levels of *Legionella*. The guidelines stress that until further data are available to demonstrate that maintenance procedures eliminate the risk of *Legionella* transmission and associated Legionnaires disease in water fountains with specific designs, water fountains of any type should be considered at risk of contamination with *Legionella*. Healthcare facilities should follow current healthcare facility construction guidelines, which state “Fountains and other open decorative water features may represent a reservoir for
